Zimbabwe Dam Safety Study

In 2011, the Zimbabwe National Water Authority (ZINWA) requested technical assistance from the World Bank to undertake a review of the safety of dams in Zimbabwe; consultants from Arup Pty were appointed to complete the task. The project's objectives were to assess the overall condition of dams in Zimbabwe in order to make recommendations for a Dam Modernization and Operation Improvement Program (DMOIP), and to identify urgent dam safety measures for quick implementation while the longer-term DMOIP was being prepared. In December 2011 and January 2012, three teams of experienced dam engineers visited the 25 dams to be assessed in the study; two specialist teams (led by a geologist and a mechanical and instrument engineer) were then asked to visit selected dams for further assessment. The results of this review are summarized below. The full study is available at the World Bank.

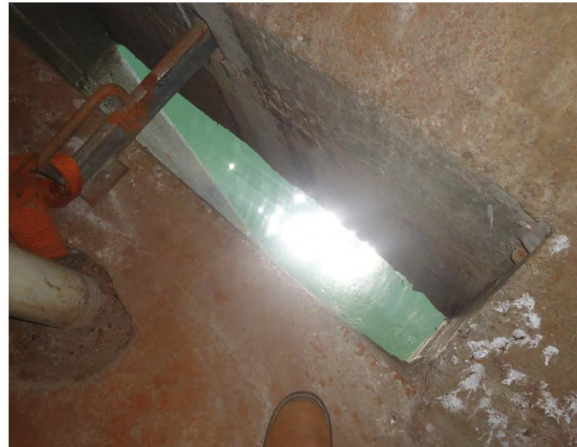
Osborne Dam: Overall, this dam is safe and most necessary repairs could be carried out as normal maintenance. However, the hydraulic works are in urgent need of repair and attention, posing an immediate risk to the operation of the dam. Although these repairs are projected to be relatively inexpensive (under \$500,000), they will be time-consuming and complex as a diving contractor will be required to assess the potential for repair.

Osborne: Service gate stuck in half-open position

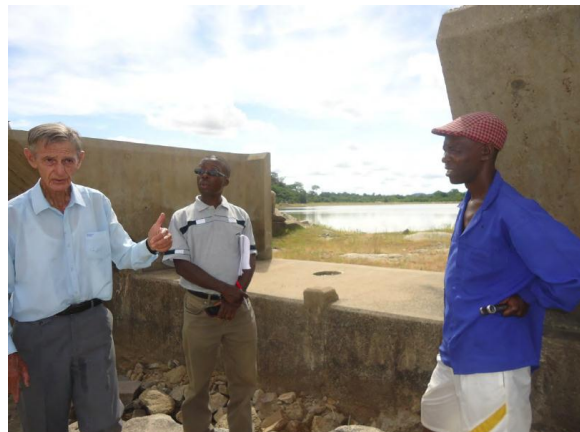
Ruti Dam: The Ruti dam is essentially safe, but it is not being utilized to its full potential. A large amount of potential water for the reservoir is being lost through a damaged fuse gate on the main spillway, and there is serious leakage in the saddle spillway that the dam bailiff has reported could result in a breach.

Ruti: Gap left by tipped fuse gate

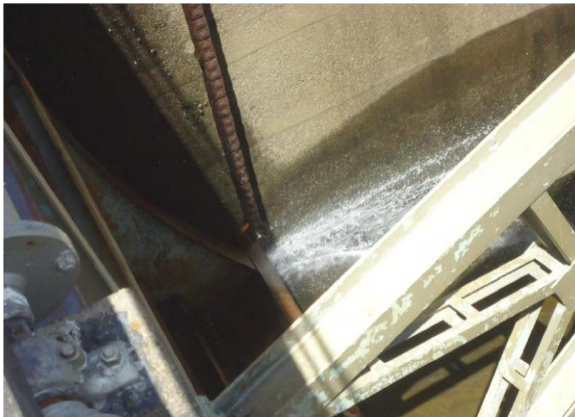
Rusape Dam: This dam needs significant refurbishment to both its electrical and mechanical systems, although its major structural components are sound and are considered safe. A lack of routine maintenance has caused failures in the mechanical equipment. Total repairs to the dam could be relatively costly with estimates up to \$3 million.

Rusape: Leak in right gate

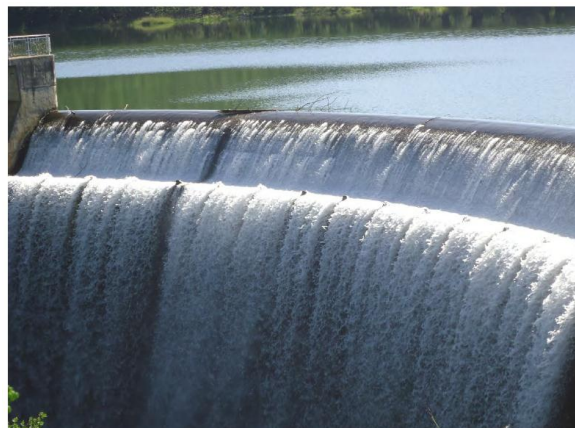
Odzani: Spillway

Odzani Dam: The Odzani dam is well designed and maintained. It is the only dam in the study that requires no major repairs beyond routine maintenance. The biggest operational issue at the dam is the lack of a boat so that the bailiff, who is also in charge of the Smallbridge dam approximately 2 kilometer upstream, has no easy way of commuting between the dams.

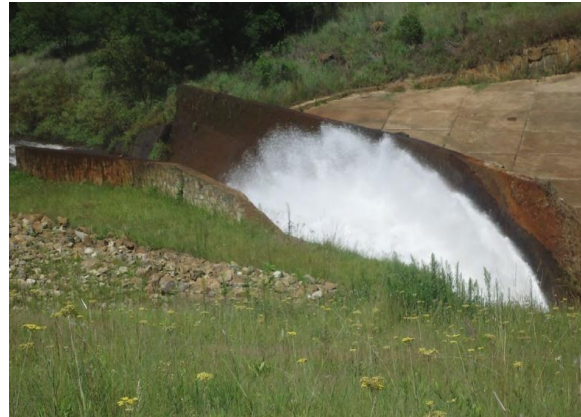
Smallbridge Dam: The dam is safe, but needs emergency maintenance to control leaking outlet valves. These repairs are projected to be relatively inexpensive (under \$100,000), but the emergency gate system must be replaced before these repairs are undertaken. Without a functioning emergency gate, the water level could need to be dropped for repairs to be possible. This could result in a total loss of storage, which would pose a serious threat to the water security of the City of Mutare.

Smallbridge: Water gush from a jammed valve in the outlet

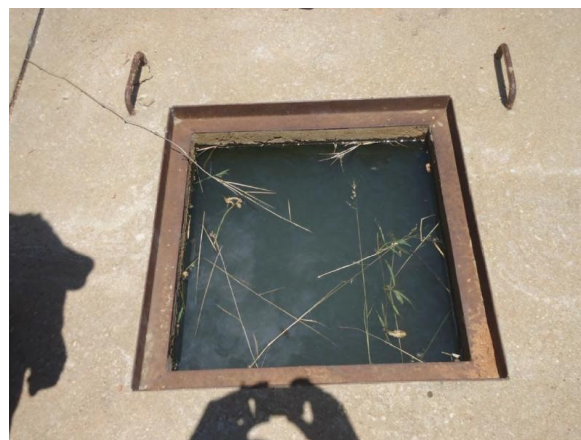
Mupudzi Dam: The full potential of this dam for irrigation is not being utilized. Urgent repairs are needed to the valve house which is currently flooded, preventing adequate control and maintenance of the valves. The lack of a boat means that the bailiff needs to swim to the intake tower to perform general maintenance.

Mupudzi: Flooded valve house

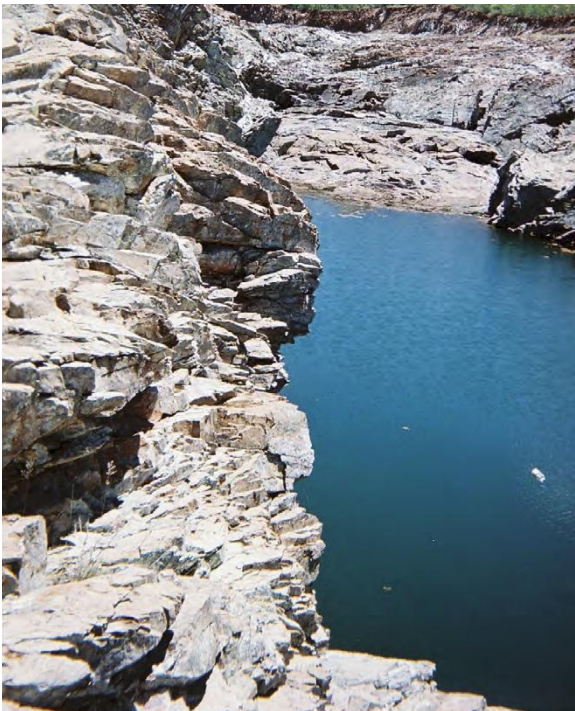
Muzhwi: Spillway return channel

Muzhwi Dam: The situation at the dam is critical and needs addressing urgently. Emergency attention should be given to the full refurbishment (or part replacement) of the outlet works—service gates and all valves—and operating mechanisms. The design for the mechanical works needs to be re-evaluated as previous maintenance has altered some design features.

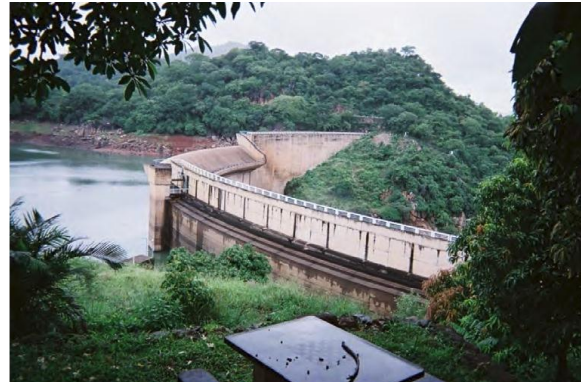
Bangala Dam

Bangala Dam: Staff levels and facilities at this dam should be improved, and routine maintenance carried out to a better standard. Significant repairs need to be performed on the outlet works.

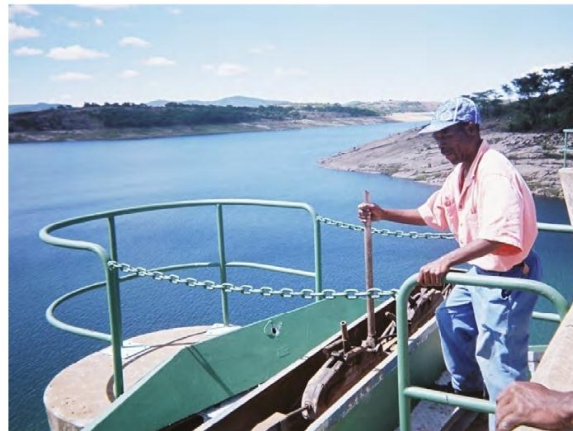
Mutirikwi Dam: The structure of this dam is in good condition, but significant refurbishment of the entire outlet system is necessary, and would best be undertaken by a specialist contractor. Monitoring should be resumed on deflection targets, crest level studs, and strain meters, and on a large horizontal crack.

Mutirikwi: Manually operated dam gate mechanism

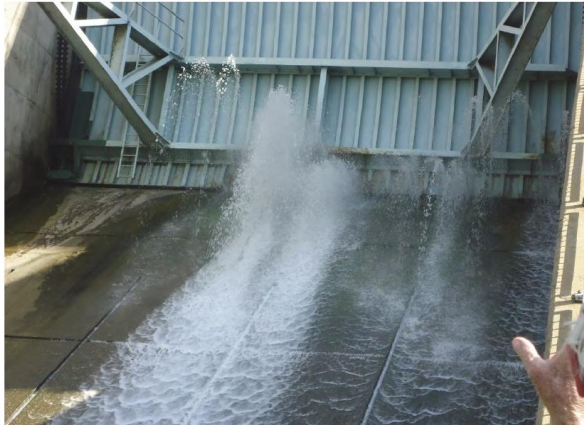
Manyame Dam: Significant problem areas involve the dam outlet works and leaking spillway gates. Non-functioning electrical equipment means that mechanical components, such as the heavy spillway gate, must be manually operated. The dam surveillance system also requires complete upgrading.

Manyame: Leakage in the radial spillway gate

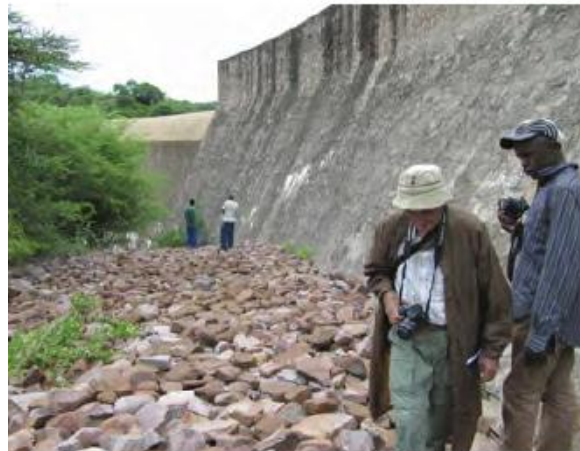
Lungwalala Dam: The Lungwala dam will require the most expensive and complex repairs of all dams in the study with estimated costs as high as US\$10 million. The dam has urgent seepage losses on both left and right bank which need to be investigated further and addressed. Major civil engineering works will be needed to correct the problem.

Lungwalala: Leakage from the left bank

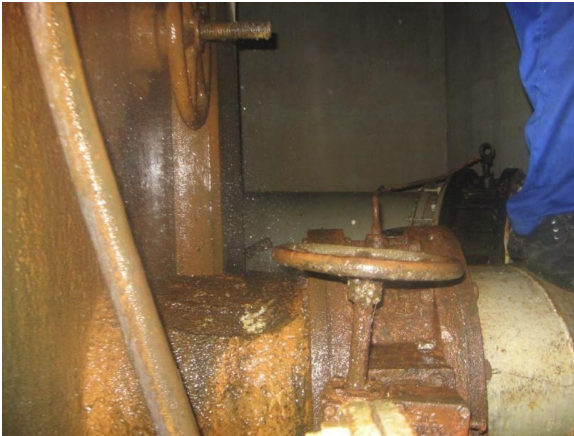
Mwenje Dam: Mwenje dam is a well designed and constructed dam and required repairs are relatively inexpensive. The outlet works will need some rehabilitation that may require a specialized contractor. Some monitoring equipment also needs replacing.

Mwenje: Rusted butterfly valve pipe

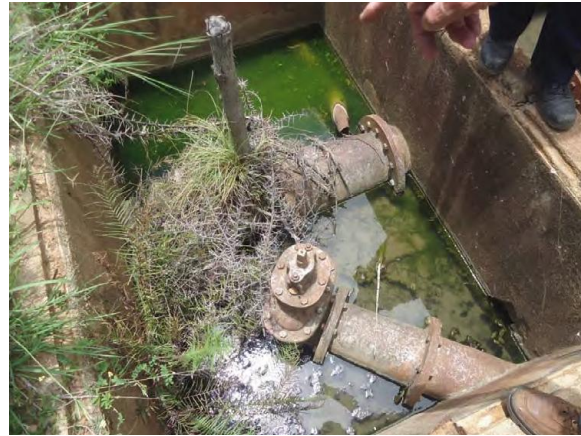
Ngondoma: Outlet pipe with a tree stump blocking a leak

Ngondoma Dam: Immediate attention should be given to the operation of the upstream close-off to enable the refurbishment of the outlet pipe and valves controlling the releases. The spillway tilting gates need to be properly maintained and tested to ensure operation. These repairs may be relatively complex and expensive (up to US\$1.5 million).

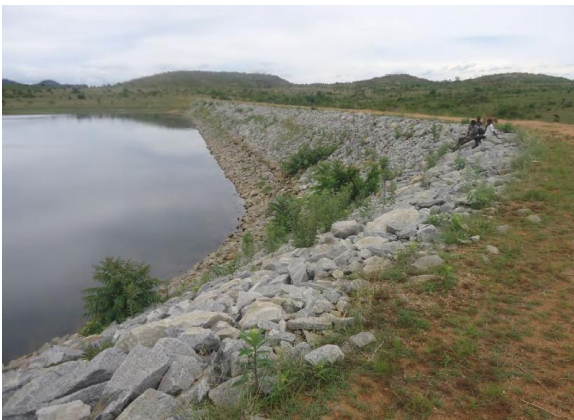
Negomo Dam: The Negomo dam is not being adequately maintained: there is excessive growth of vegetation on the upstream and down-stream slope, and there is no security fence, which leaves it accessible to both people and animals who create foot paths that later turn into gullies. The outlet exhibits signs of distress that must be investigated further on an urgent basis.

Negomo: Weed growth on rip rap

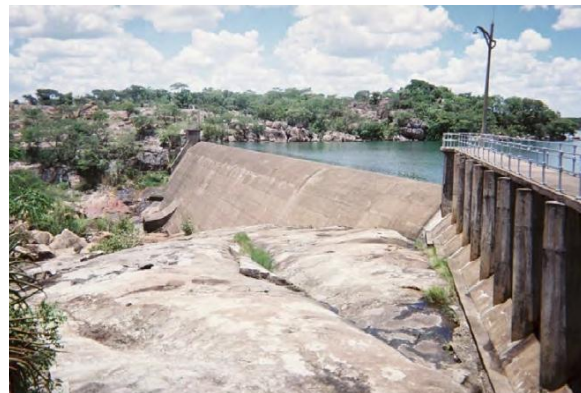
Ngezi Dam

Ngezi Dam: The Ngezi dam is a very important supplier of both irrigation and drinking water. Because the dam was designed to earlier flood estimates, the construction of a new wave wall 90 centimeters high will be urgently necessary to protect from extreme flood events. Immediate attention should be given to refurbishment (or part decommissioning) of outlet works, and a specialist contractor engaged for the refurbishment of the crest concrete of the main dam and of the auxiliary spillway.
