# NATURE BASED LANDSLIDE RISK MANAGEMENT PROJECT IN SRI LANKA

## LANDSLIDE RISK MANAGEMENT PLAN FOR TWO PILOT SITES

May 2019

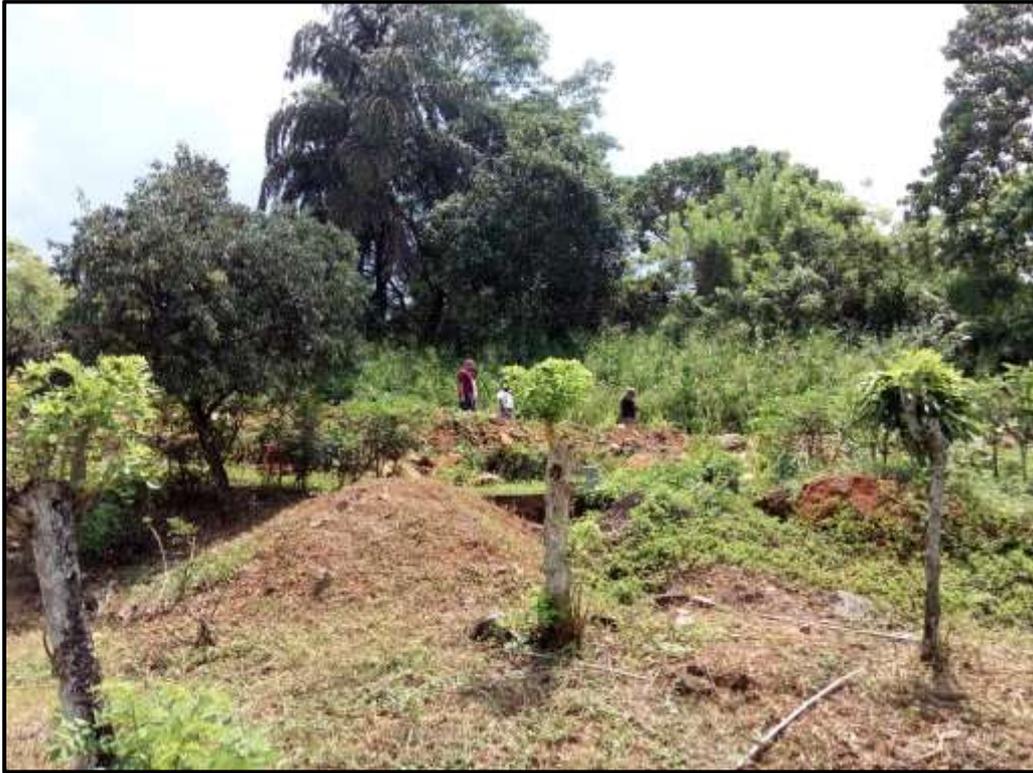
Figure 1.3: Upslope and down slope areas of the failed mass

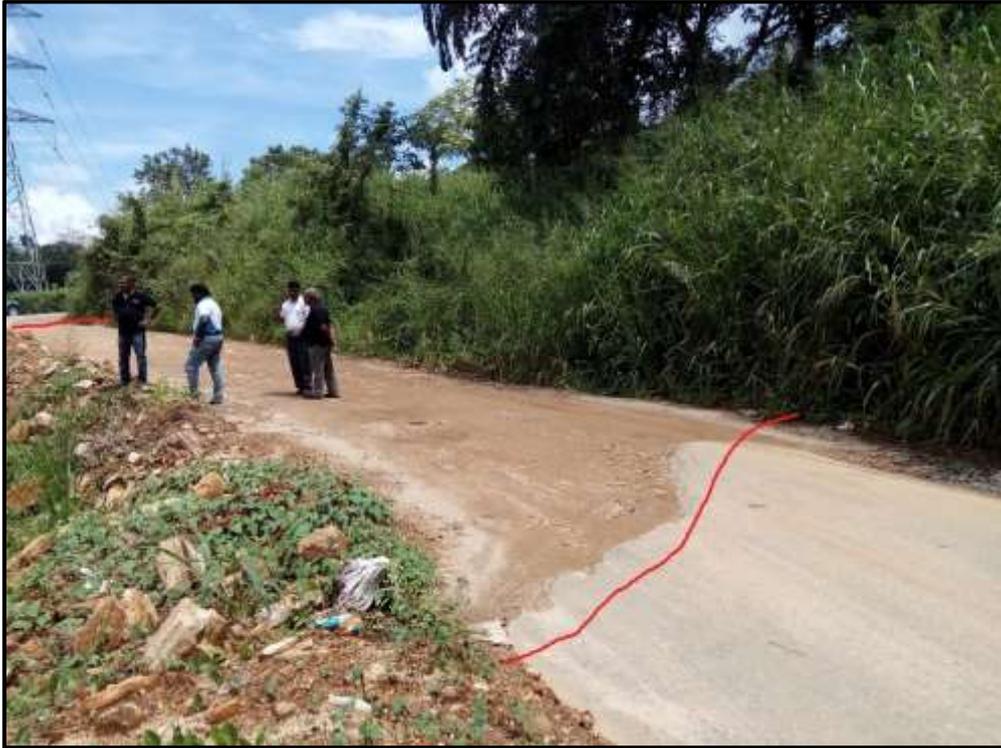
Figure 1.5: Red lines demarcating the affected road section

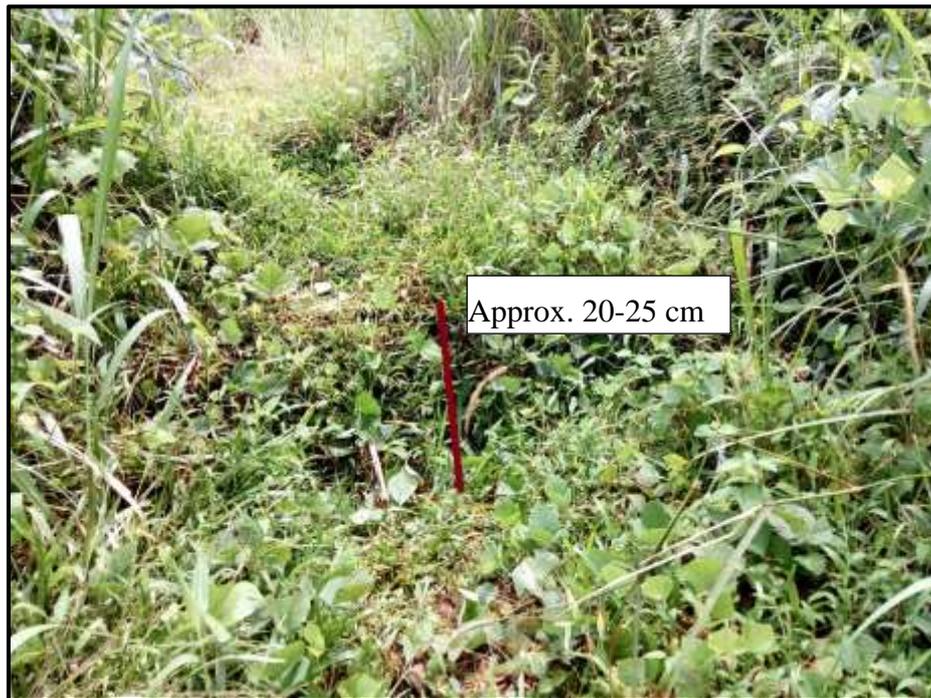
The Crown area of the failed mass is densely covered with vegetation such as *Mangifera indica* (Mango) and *Caryota urens* (Kithul). Scars of ground subsidence are seen scattered around the area. A cemetery is located at the up slope area and is affected by ground movements.

Figure 1.7: Ground subsidence observed at site

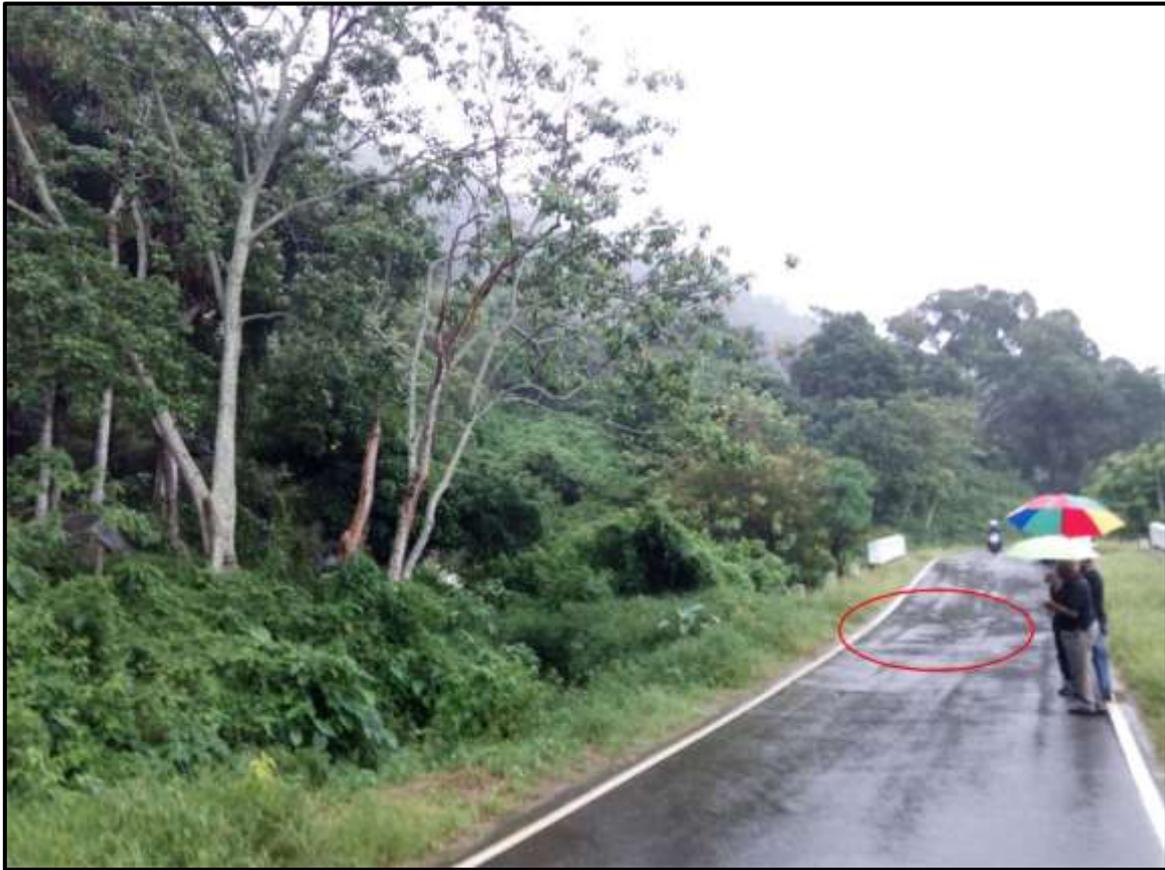
Figure 1.9: Some vertical displacement observed on the road stretch

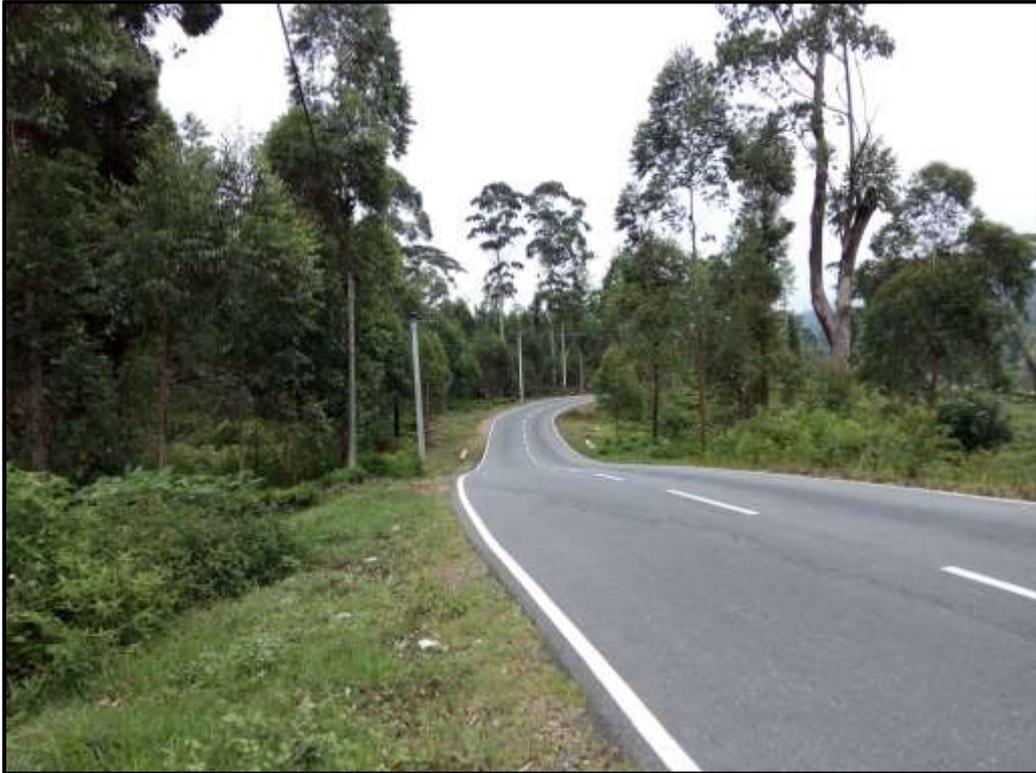
Figure 1.15: Vertical displacement observed in the road stretch due to ground movements

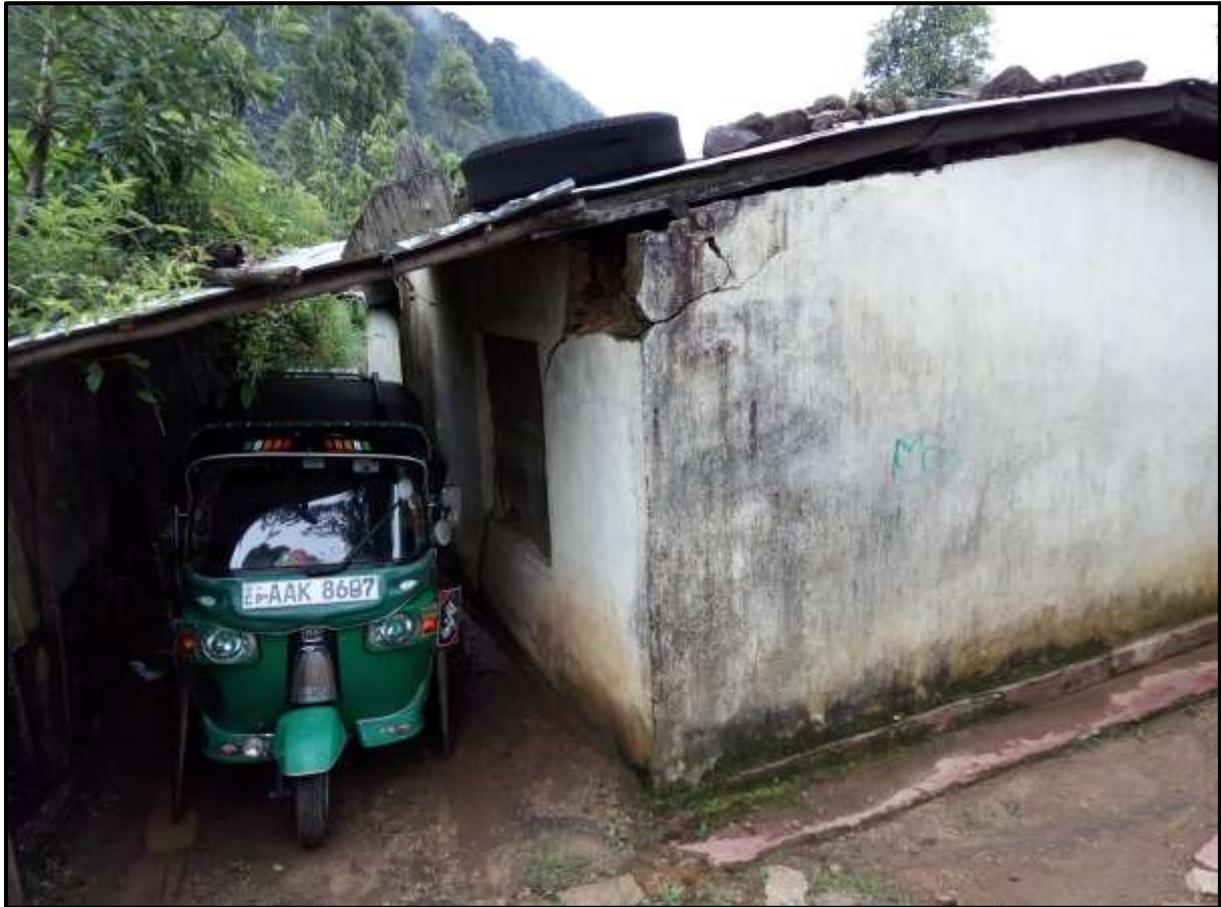
Figure 1.17: A damaged house due to ground movements

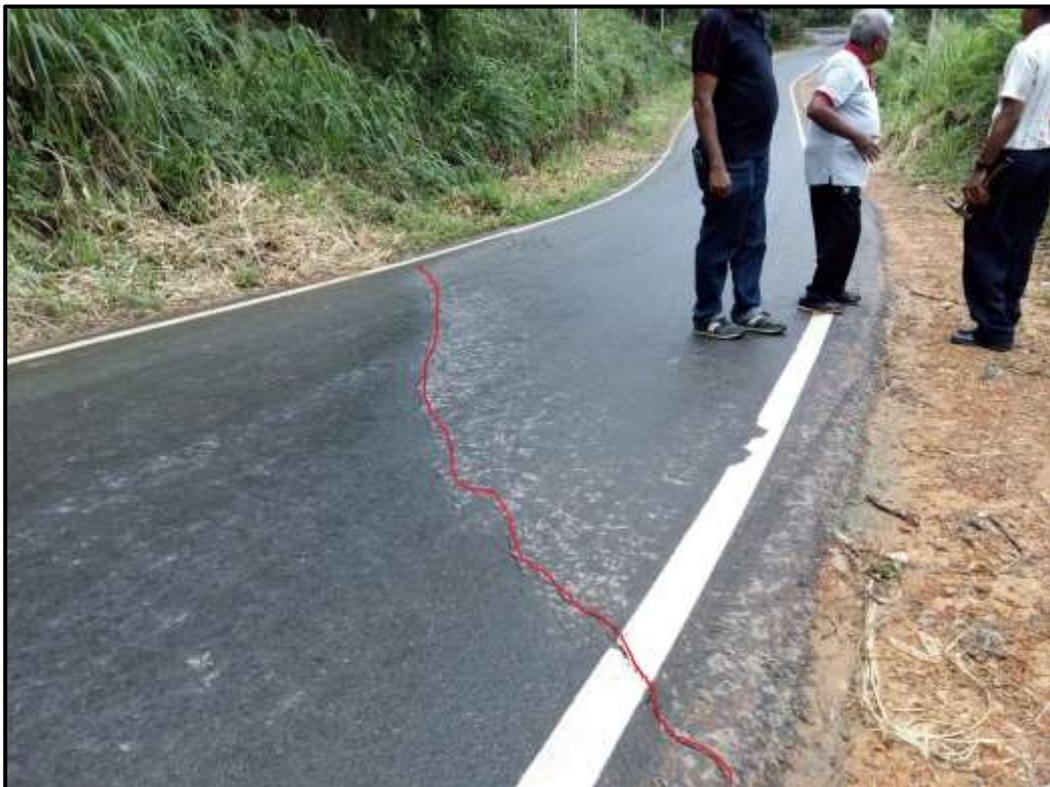
Figure 1.20: A crack on the road stretch marked with the red line

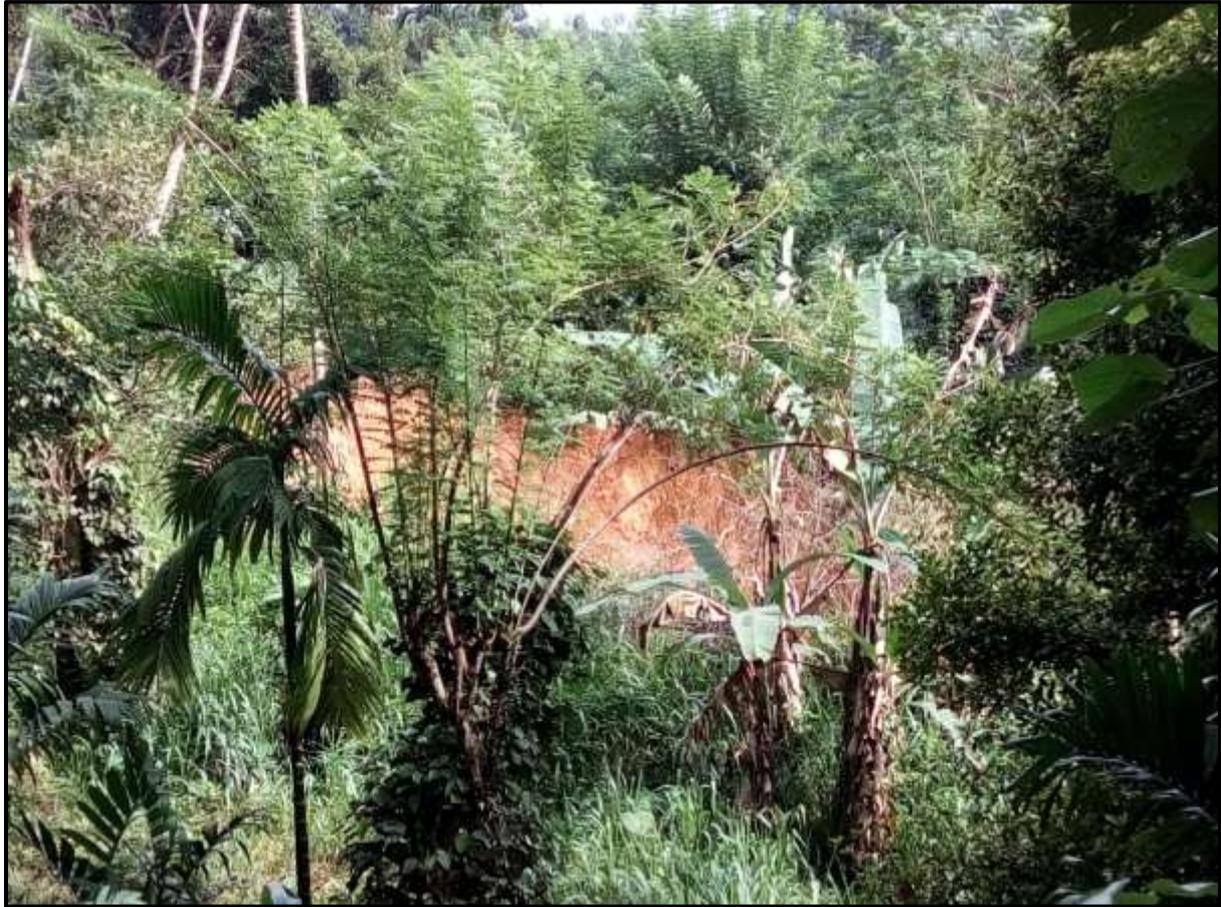
Figure 1.21: A previous landslide scar which had during heavy rainfall in May 2017

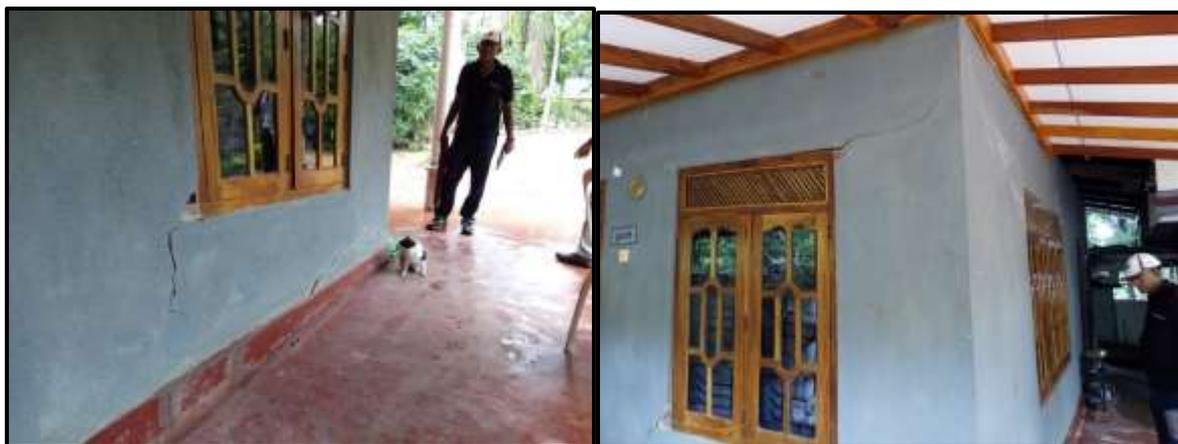
Settlement cracks were seen on a residential building due to ground movements (Figure 4.15).

Figure 1.22: Settlement cracks observed on a house due to ground movement

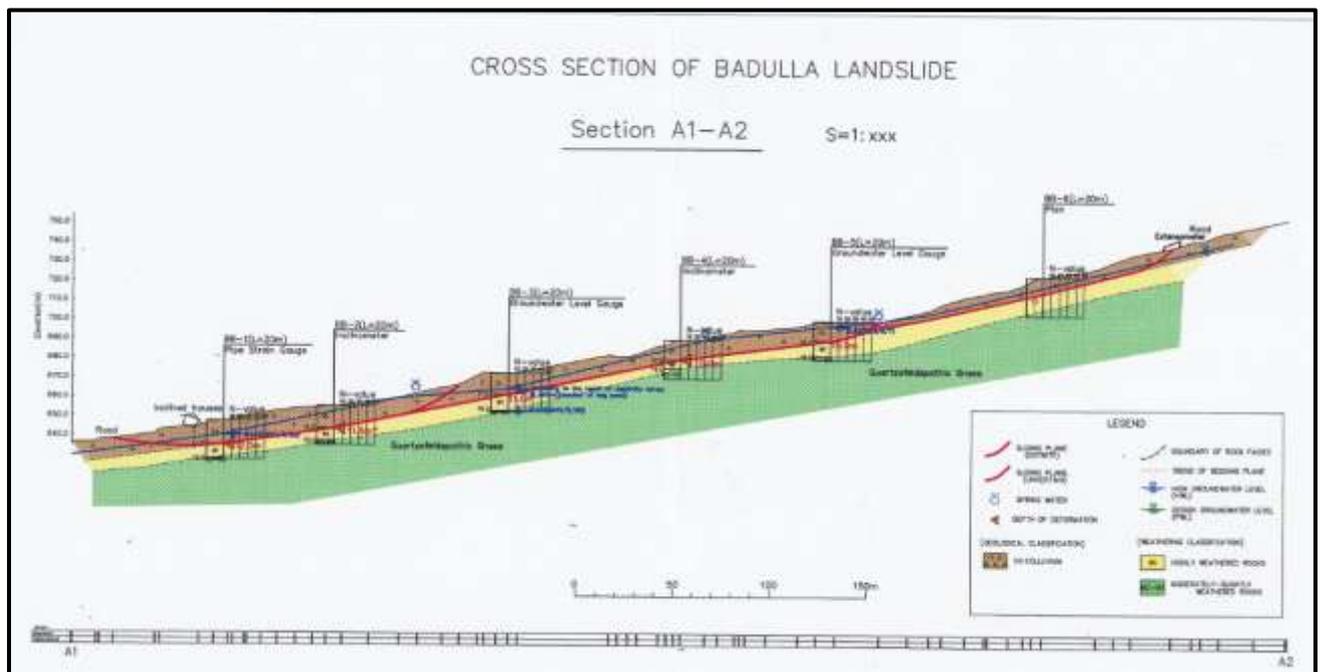
JAICA team of investigation had identified three main failure surfaces at a maximum depth of 9-10m from the existing ground level (Figure 5.6). All three surfaces move along the interface between Colluvium Soil layer and Highly Weathered Rock layer. The proposed failure surfaces were supplemented with slope movement data which were extracted from the Site. (Nishikawa & Balasooriya, 2016) (Countermeasures for Badulusirigama-JAICA, 2015)

Figure 5.1: Cross section of Badulla Landslide along its main axis (Countermeasures for Badulusirigama-JAICA, 2015)

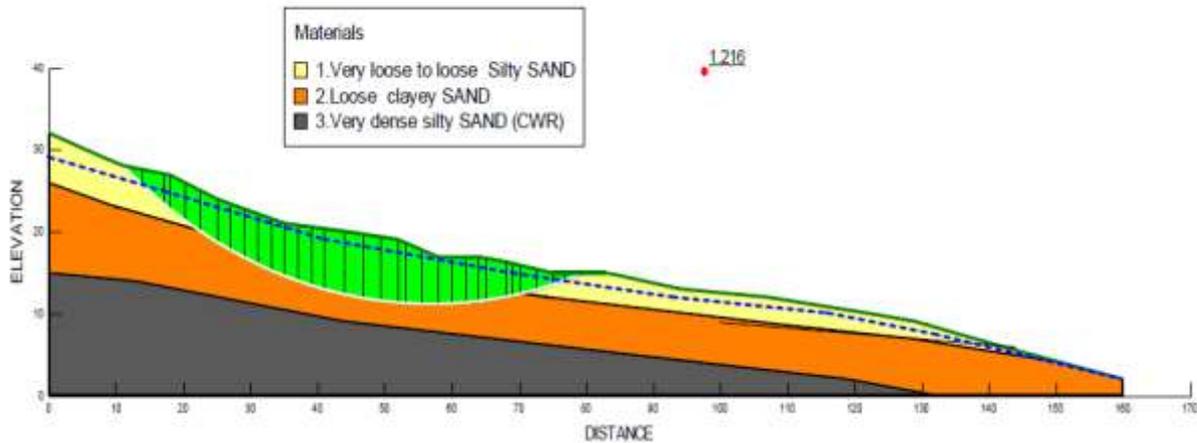
Figure 5.5: Stability condition of the existing slope

The failure plane is at a depth of around 9 – 10.0 m, which indicates the failure is of deep seated type. The current computed factor of safety is around 1.2. This analysis more or less simulate the existing slope conditions, as per the monitoring data and general observations made during site inspections.

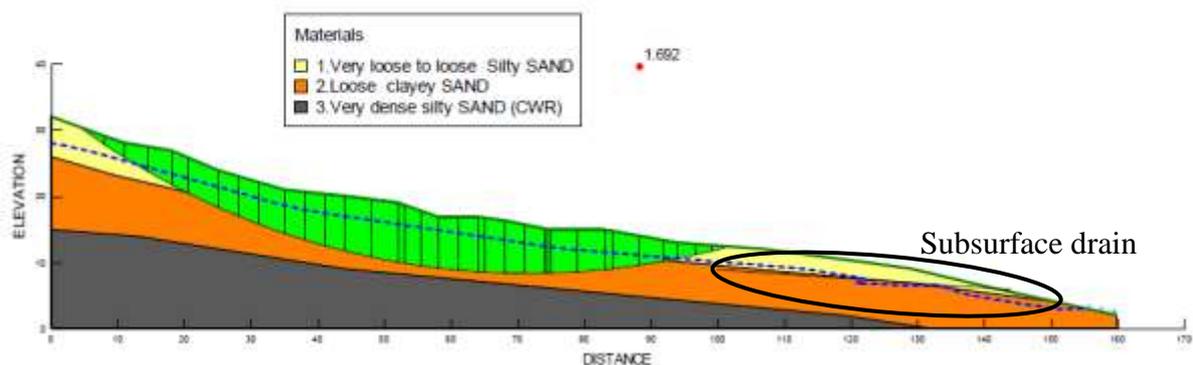
Figure 5.6: Stability conditions after the introduction of the subsurface drain

The factor of safety has been increased to a value of 1.692 which was around 1.216 previously. But still the critical failure surface is deep seated. However, it can be decided that subsurface and surface drainage improvement will be a good measure to rectify this deep seated slide.

A subsurface drain was introduced to lower the water table. The location and the length of the drain was selected based on the information on seepage conditions of the site.
