Guatemala – Study on Disaster Risk Management of Cultural Heritage

The case of Antigua Guatemala

Guatemala – Study on Disaster Risk Management of Cultural Heritage The case of Antigua Guatemala

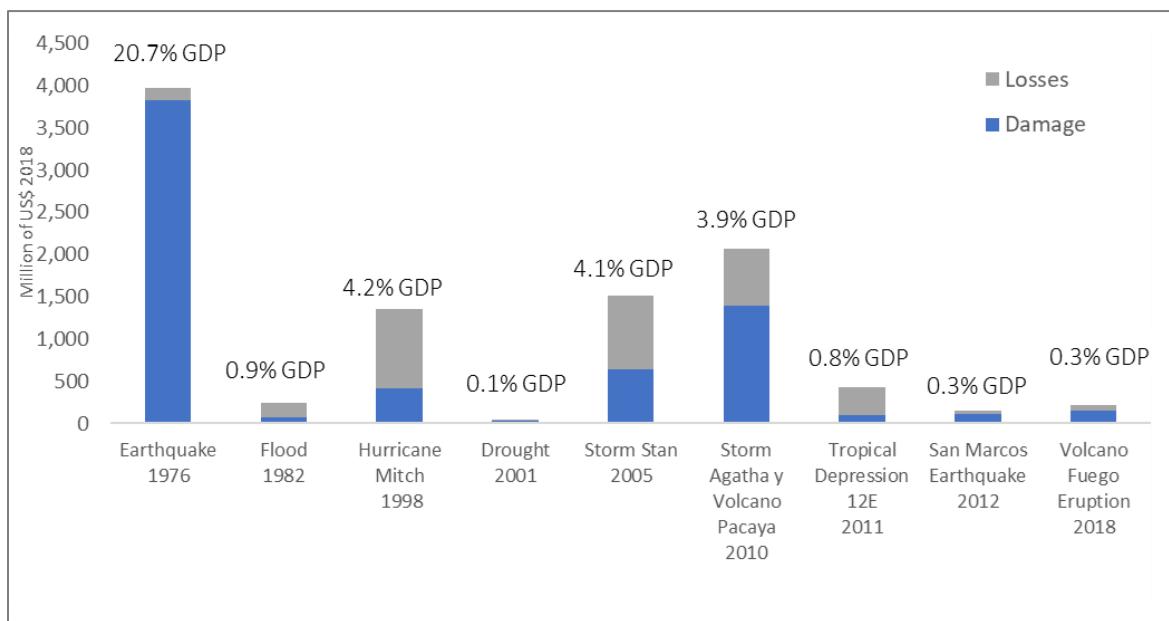
Fig. 1: Damages and Losses from the Most Significant Disasters in Guatemala (2018 US\$, millions and percentage of GDP) (Source: Damages and losses data extracted from post-disaster needs assessments compiled by GFDRR).

In total, from 1975 to 2018 the most significant disasters in Guatemala provoked damages and losses amounting to US\$9.8 billion. This represents an annual average cost of US\$228 million, equivalent to 0.30 percent of GDP (2017). While disasters originated by hydrometeorological hazards are more frequent, their economic impacts have not exceeded 5 percent of GDP. Seismic events are less frequent but can have more devastating impacts (see figure 1).

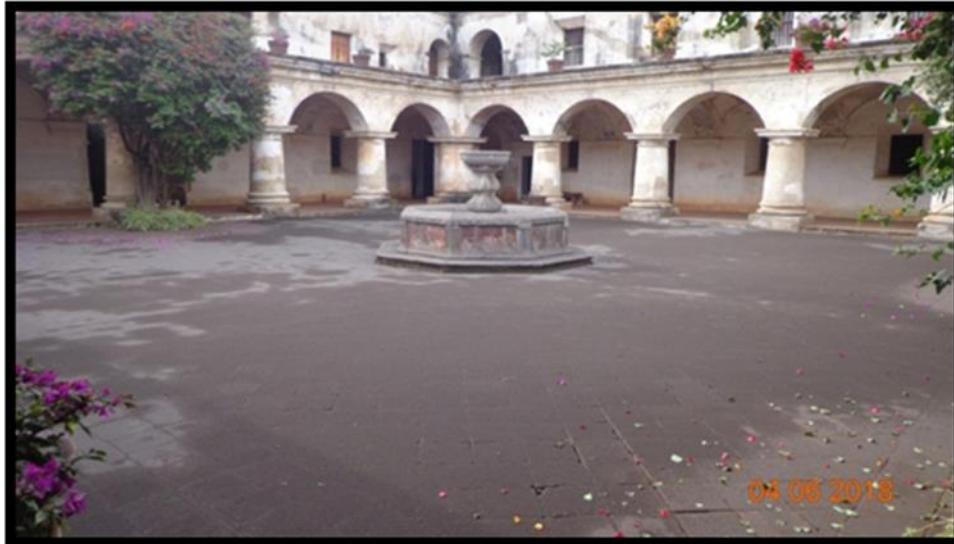
Fig. 2. *Templo de las Capuchinas'* courtyard and fountain, covered by ashes [Photo: CNPAG, 2018].

- **In Antigua there were no pyroclastic flows, but there was ash falling over streets and buildings, affecting heritage assets,** which was aggravated with the rain of the following days. The accumulation of ash on roofs combined with persistent rain causes different types of problems: the ash compacts and

retains water causing leaks, especially serious in historic buildings; due to high mineral content, ash promotes the growth of vegetation on roofs, affecting maintenance; it can also affect the pipes, clogging them and even causing them to collapse.

- **The cleaning process—including roofs, streets, public spaces, etc.—lasted approximately one month, collecting tons of ash.** Not all the heritage buildings could be cleaned due to lack of resources, and lack of cleaning system or guidance for cultural heritage. According to the CNPAG inspection, the most affected heritage assets were: roofs, courtyards mud tiles, cobblestone streets, buildings on process of being restored, interior and exterior of fountains, and rain channels, which were entirely covered by ash.

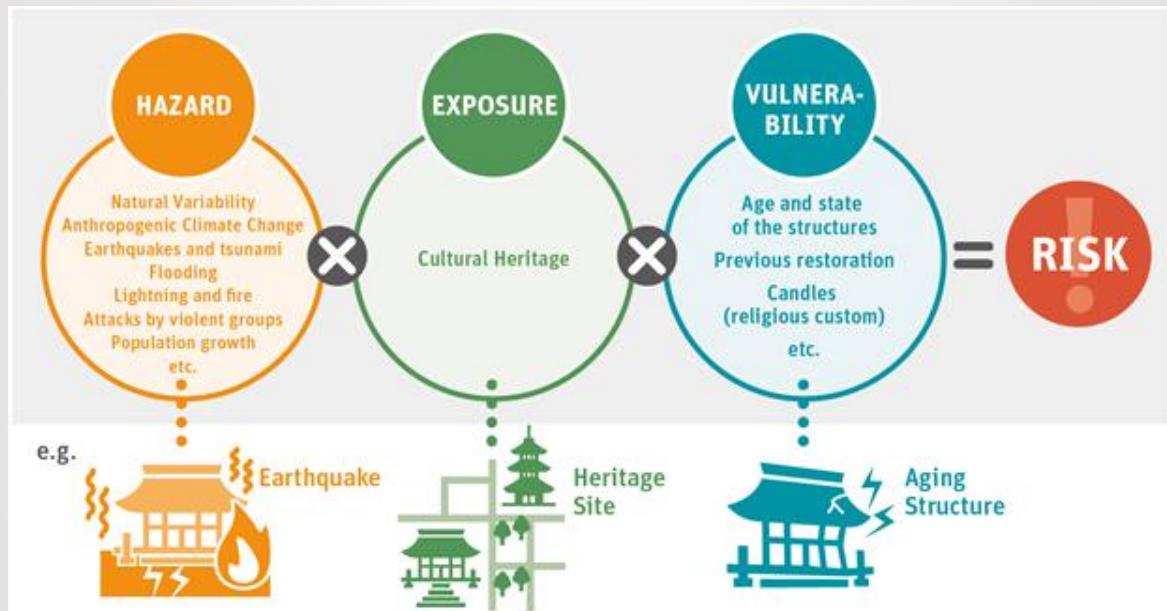
Fig. 3: Risk calculation for cultural heritage assets. Source: Newman & Minguez Garcia (2017).

In order to reduce risk, since it is not possible to reduce natural hazards, the solution comes by reducing the vulnerability, increasing the resilience of the exposed assets. In the case of cultural heritage being the exposure, the equation becomes more complex due to the particular characteristics of heritage, and because many factors, such as age, state of conservation, etc., affect the level of vulnerability. Consequently, it is fundamental to connect the experts from both disciplines, ensuring that DRM authorities take into account the particular characteristics that heritage presents, and that managers of heritage sites are aware of the natural hazards, and risks they face, in order to be prepared to respond in case of emergency. Collaboration between relevant local/national agencies, authorities, specialists, and local community is essential to ensure the effective protection of heritage from disasters.

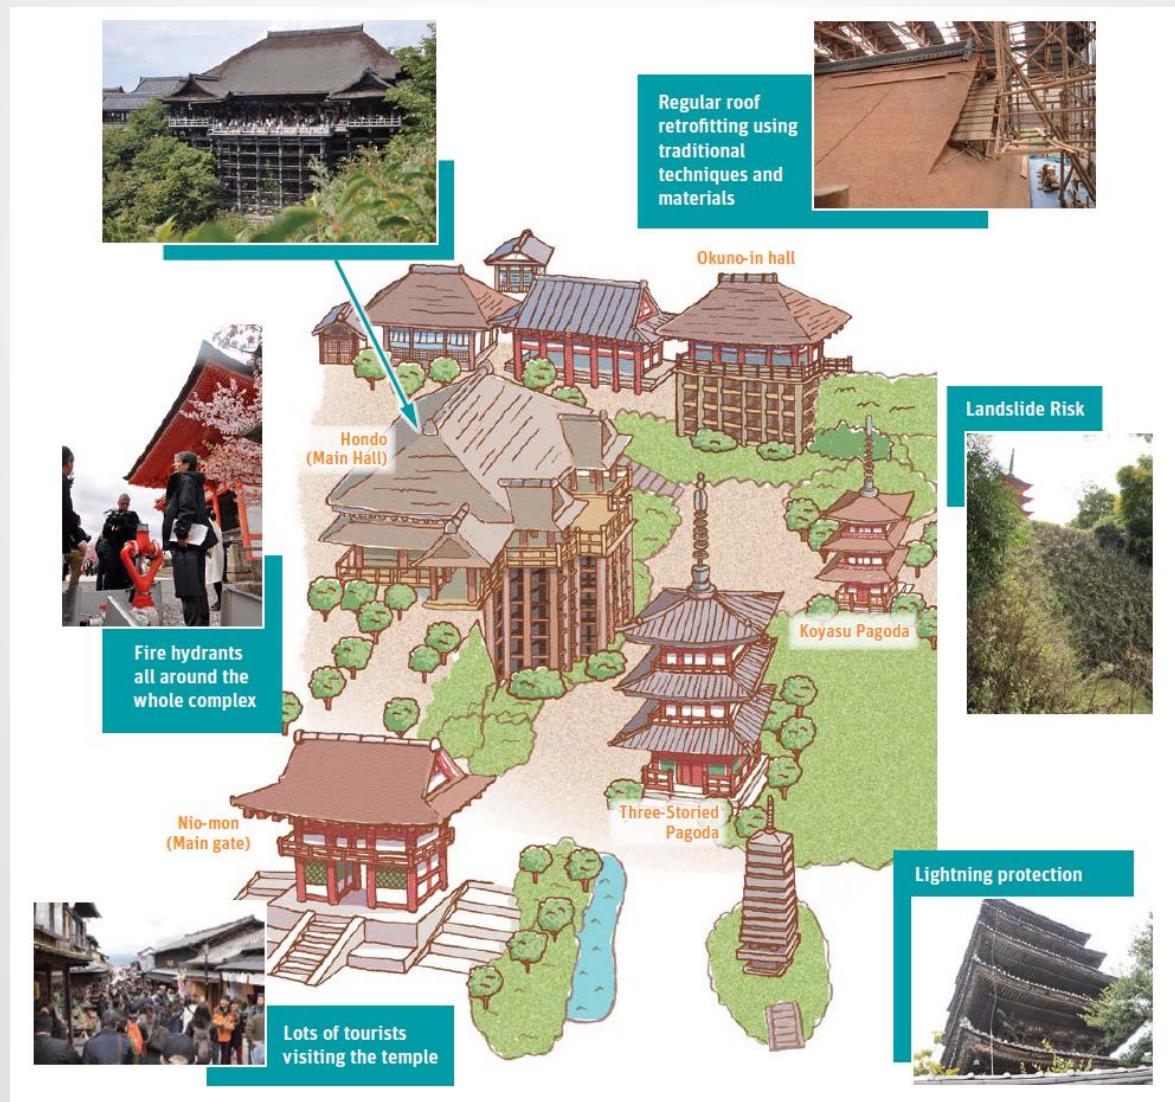
Fig. 4. Kiyomizu-dera Temple Disaster Prevention Measures (Newman y Minguez Garcia, 2017).

One of the best examples to illustrate DRM for cultural heritage is the Kiyomizu-dera area in Kyoto, UNESCO World Heritage Site. The temples have a traditional seismic-resistant architectural design, firefighting and lightning systems distributed throughout the area and camouflaged to avoid visual impact, monitoring and stabilization measures for landslides. In addition, there are innovative programs to involve and train the local community in disaster preparedness and heritage protection.

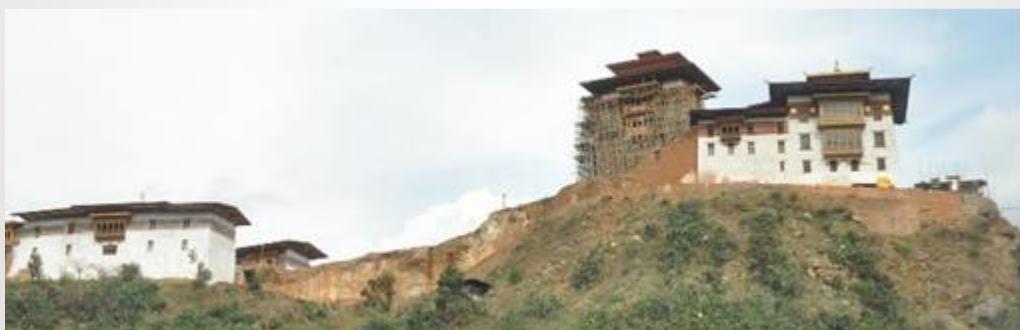
Fig. 5. Wangduephodrang Dzong, built in 1638 and burnt down during a fire in 2012 (Photo: BMG, 2018).
