SIERRA LEONE

RAPID DAMAGE AND LOSS ASSESSMENT OF AUGUST 14TH, 2017 LANDSLIDES AND FLOODS IN THE WESTERN AREA

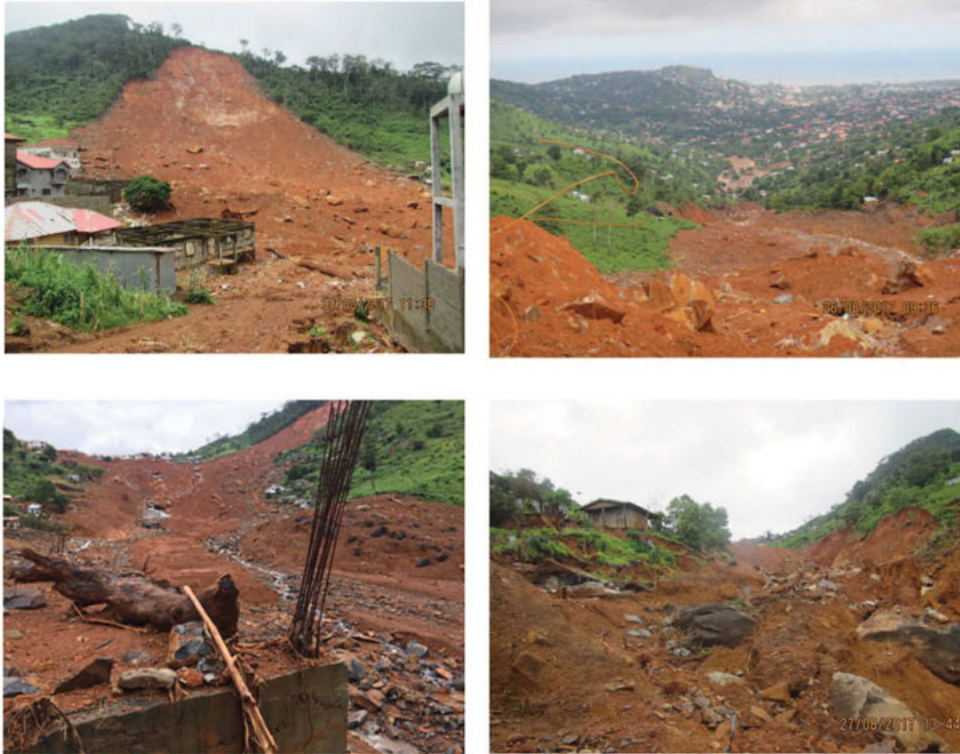
PHOTO 1: Photographs of Regent Landslide Area and Immediately Downstream along River Course

Satellite imagery pre- and post-event very clearly shows the damage caused by the debris flow to the valley floor as it advanced downstream from Regent. The river channel has changed considerably and is now much wider (100 m as shown in Figure 12) with the river course dividing in a number of locations, from its previous single course. Although Kamayama/Malama is at least 3 km from the landslide zone, it was still severely affected by the run-out and the force of

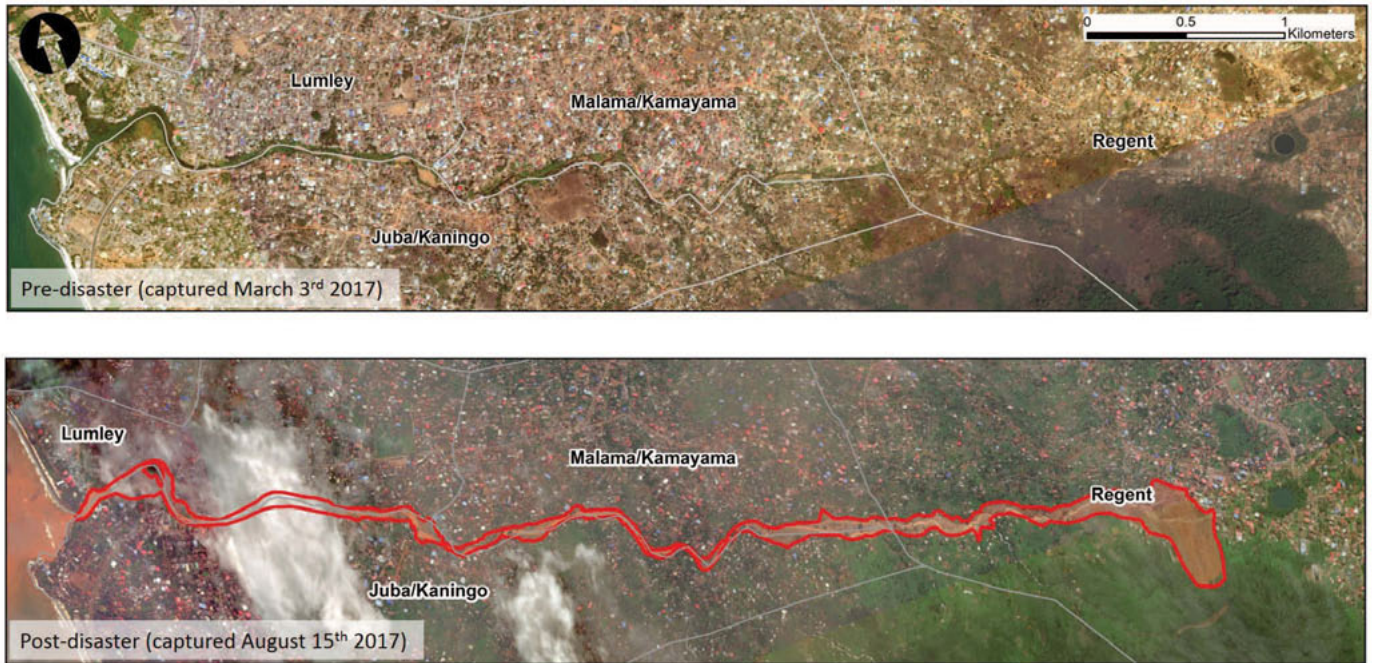
FIGURE 11: Pre- and Post-Disaster Satellite Imagery Showing the Affected Area from Regent to Lumley

deposition becomes more significant. It is likely though that tree trunks and lighter objects, including building materials, were carried further than the boulders (Figure 11).

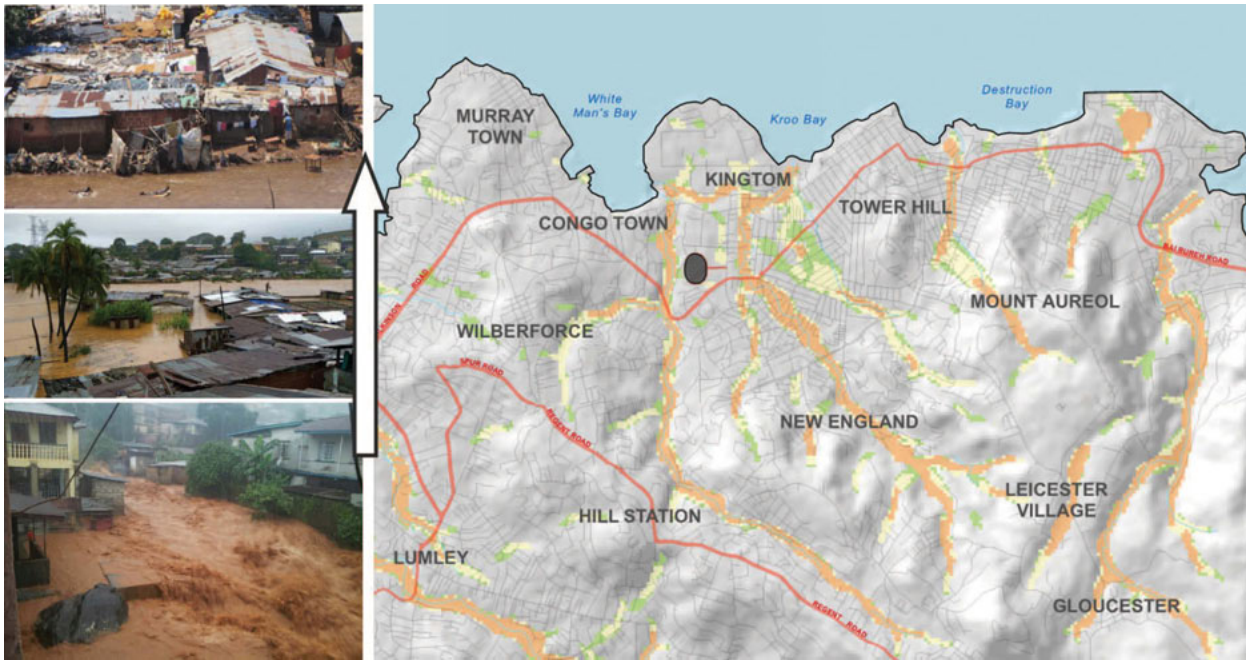
FIGURE 13: Flood Hazard in Western Area Urban, Northern Freetown—Examples of Recent Widespread Flooding from Culvert and Congo Town Regions

Note: The flood hazard changes as you move from the high mountains in the south to the lower lying flat land in the north (as indicated by the arrow).
Source: World Bank, Arup (2017).

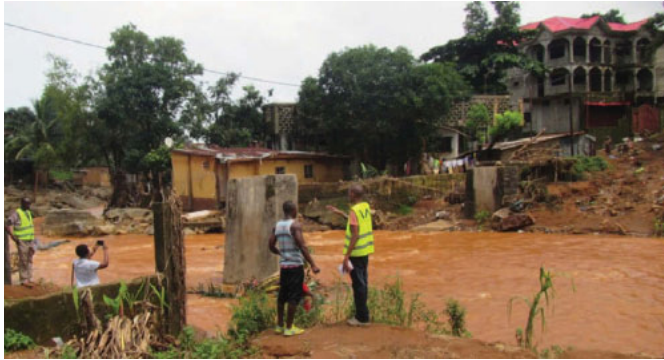
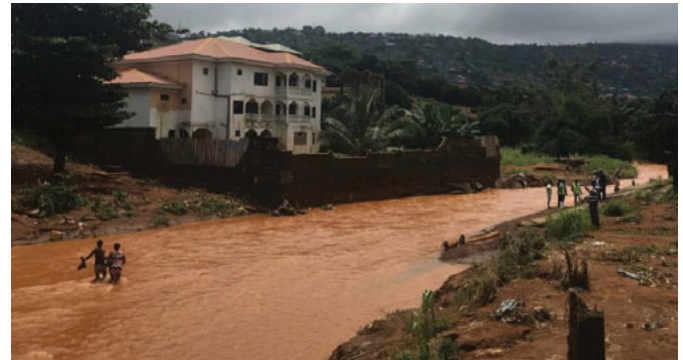
FIGURE 17: Affected Roads, Bridges and Pathways by the Regent-Lumley Landslide

Collapsed bridge at Kaningo (Sheriff Drive)

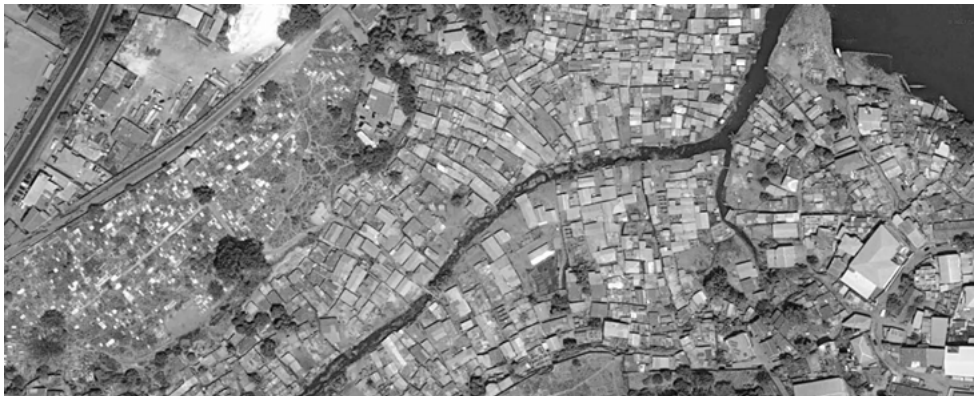
FIGURE 36: Example of High Density Area Near Estuary at Granville Brook/Bomeh Dump Site Prior to Flooding

There are two dump sites, both posing very high risks to the dense residential communities where they are located—The partially fenced Granville Brook or “Bomeh” where the garbage piles are 10–15 meters high, and the King Tom site. Less than half of the 500–600 tons of solid waste (household, medical, hazardous, and toxic waste) generated in Freetown reaches these sites (Figure 36 and Figure 37).

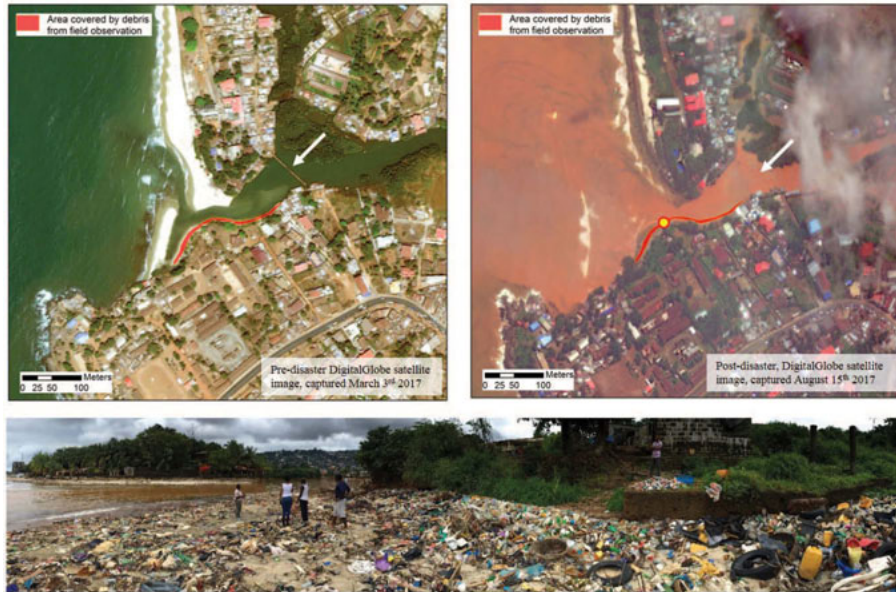
FIGURE 38: Debris at Lumley Creek Resulting from Flooding and Debris Flow Related to Regent Landslide Disaster

Note: The yellow circle indicates the location of the panorama above, which shows a view from east to west across the beach. The white arrows indicate the Lumley footbridge, which is submerged in the post-disaster imagery. The aerial extent of the debris was mapped in GIS based on field observations in the Lumley Creek area.

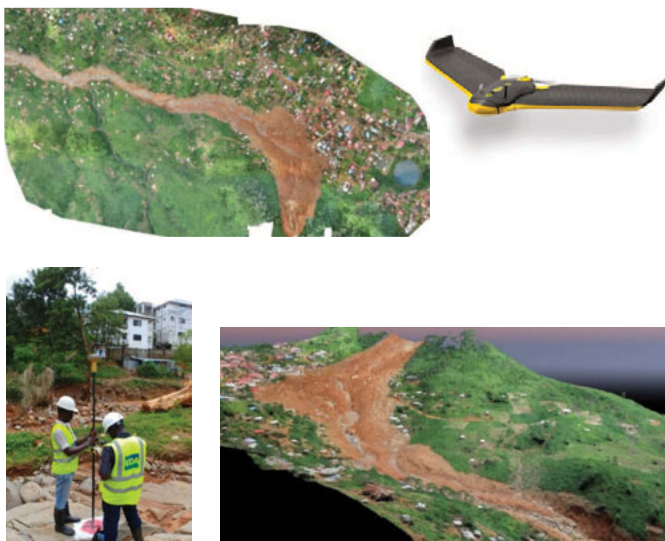
PHOTO 5: Drone Mapping of Affected Area Conducted by EDA

This assessment covers affected areas in Freetown, Western Area Urban (Malama/Kamayama, Juba/Kaningo, Lumley, Dwarzak and Culvert) and Western Area Rural (Regent). Malama/Kamayama, Juba/Kaningo, Lumley and Regent were affected by the landslide and associated flooding on 14/08/2017 (referred to as the Regent Landslide). Dwarzak and Culvert were affected by separate flooding events on 14/08/2017, unassociated with the Regent Landslide. The assessment of the buildings uses different methods to estimate the damages due to the nature of the two events as describe in the Chapter 2—where the landslide was a major high-intensity event but urban flooding is a recurring annual event in the city.
