Solar Resource Mapping in Vietnam

SITE INSTALLATION REPORT

SOLAR MEASUREMENT CAMPAIGN IN VIETNAM

Installation Report: Central Highlands (VNCEH)

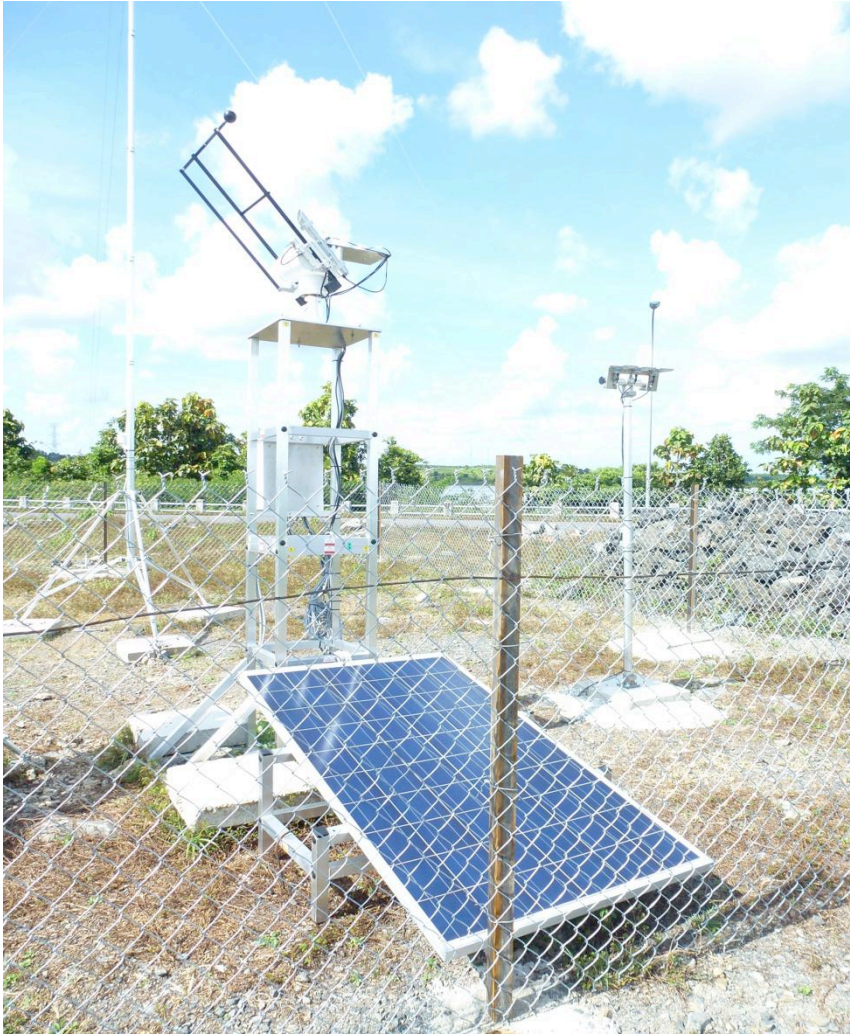
Figure 4. Photo of Tier 1 Station of type HelioScale ω installed at VNCEH

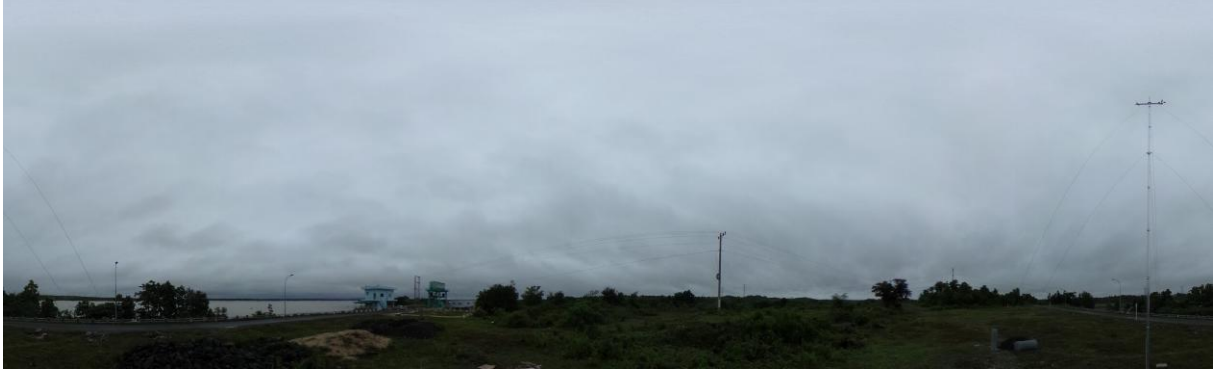
Figure 5. Horizon at VNCEH

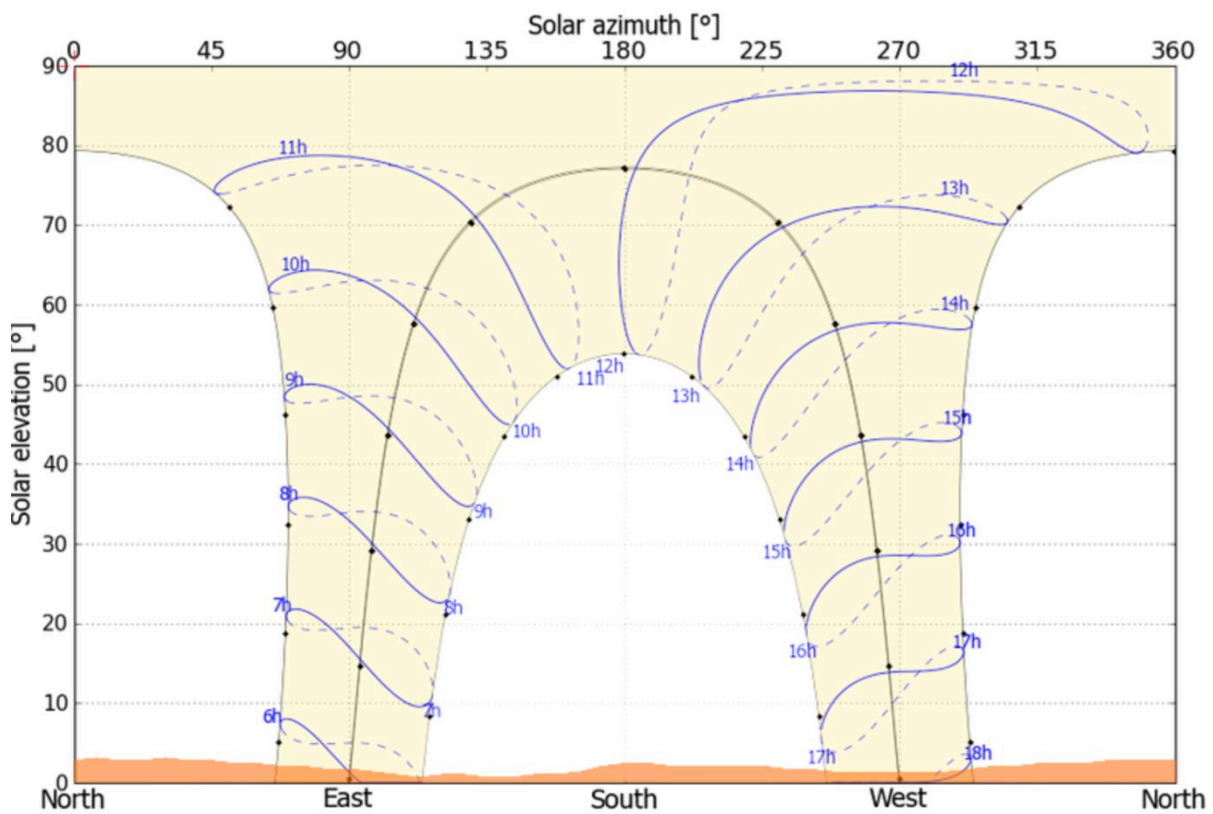
Figure 6. Sun path for VNCEH

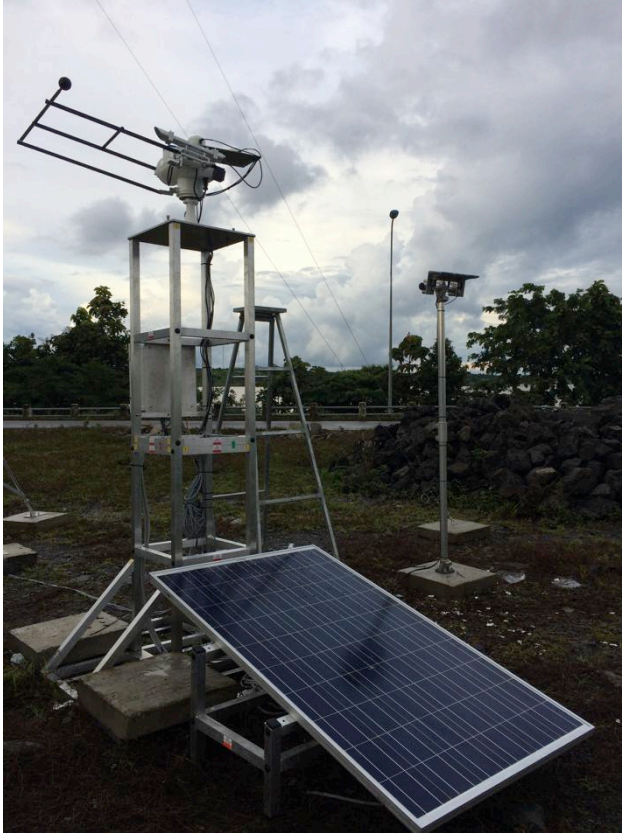
Figure 10. Sun tracker with shadow ball assembly and PV panel in the front at VNCEH. Soiling measurement on the right.

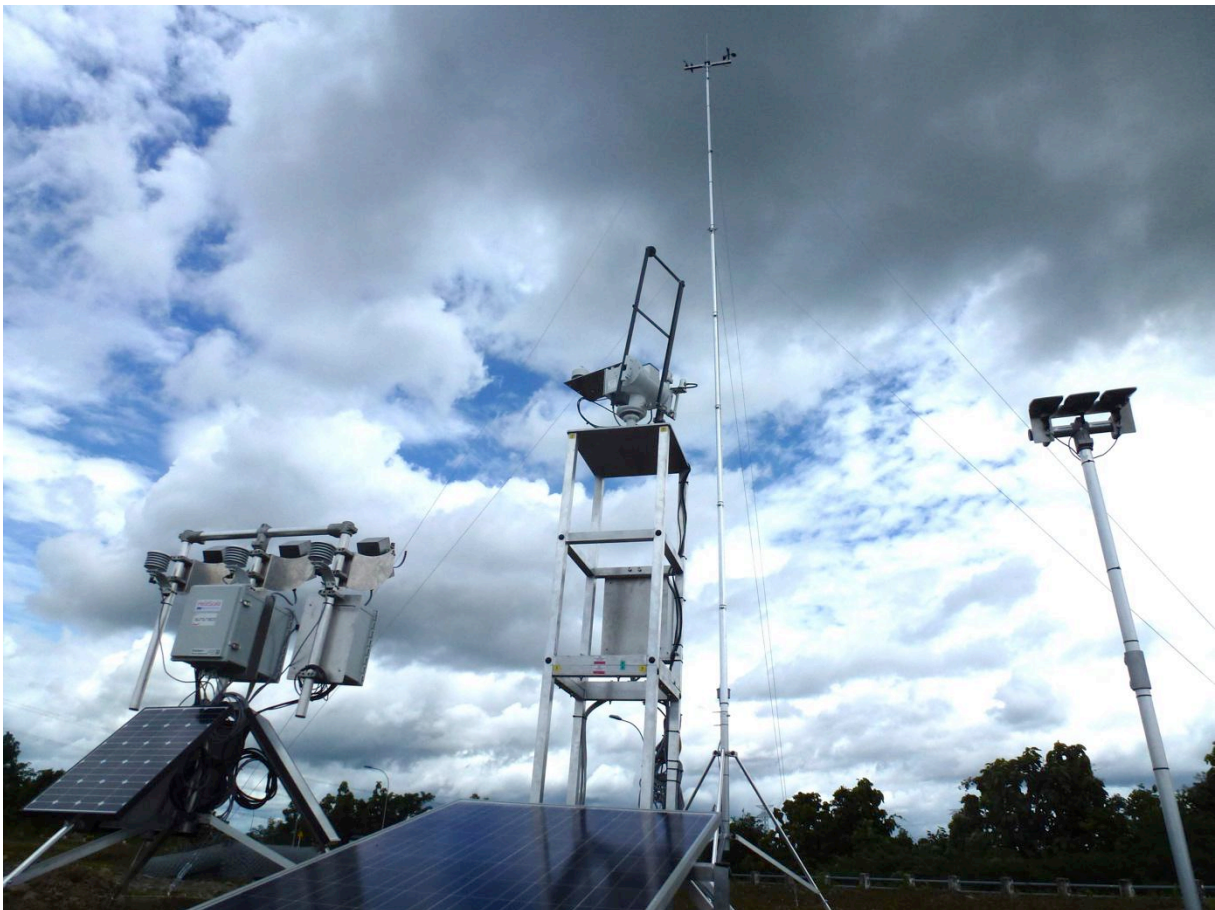
Figure 15. Complete Tier 1 station with Tier 2 calibration station at VNCEH

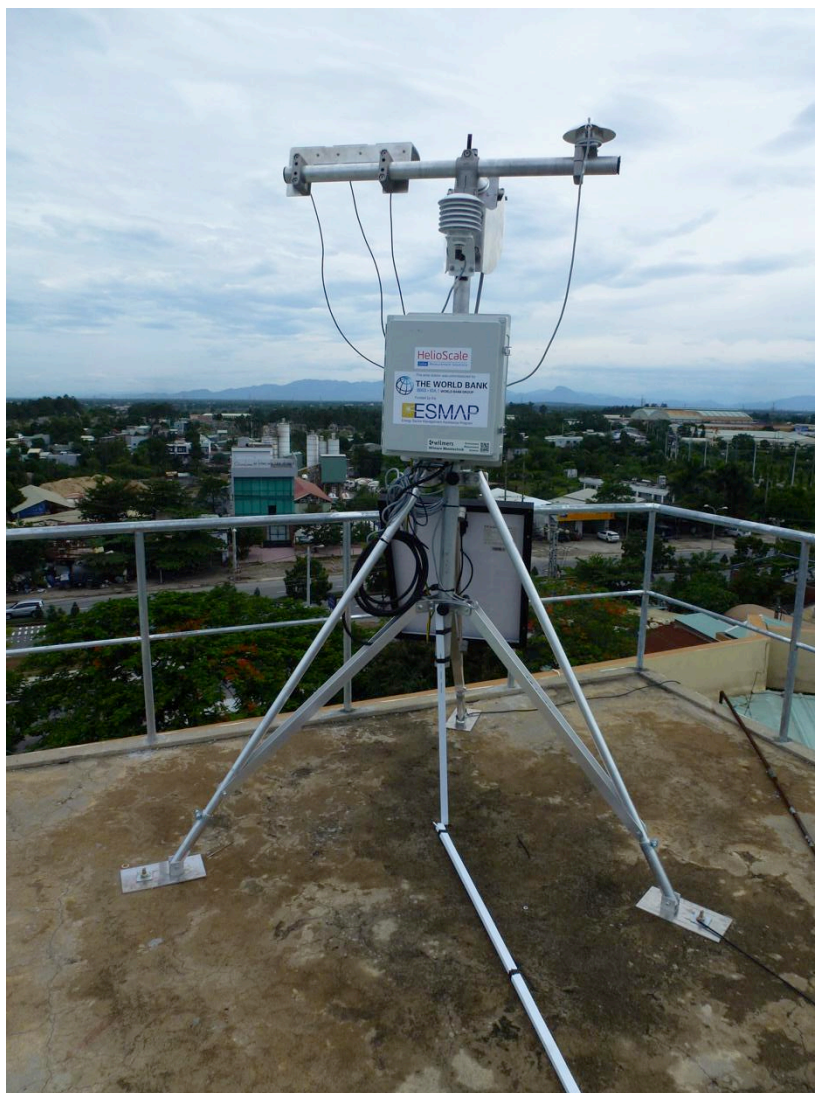
Figure 4. Photo of Tier 2 Station of type HelioScale ϕ installed at VNDAN

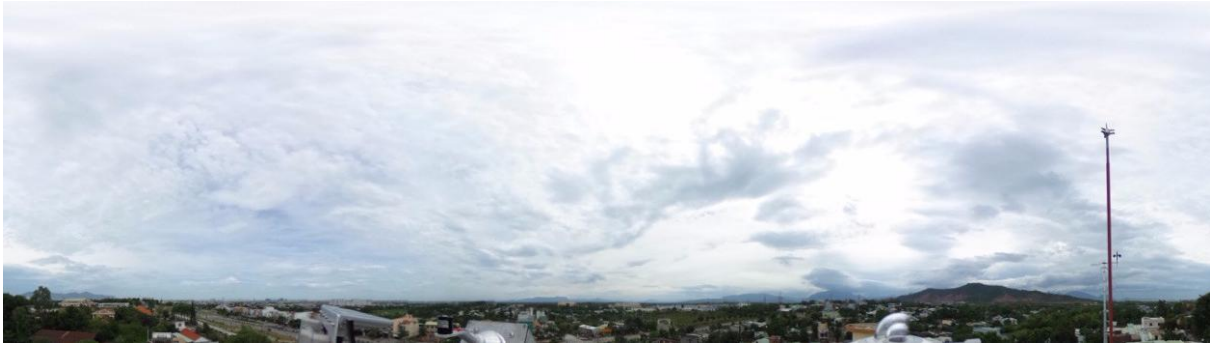
Figure 5. Horizon at VNDAN

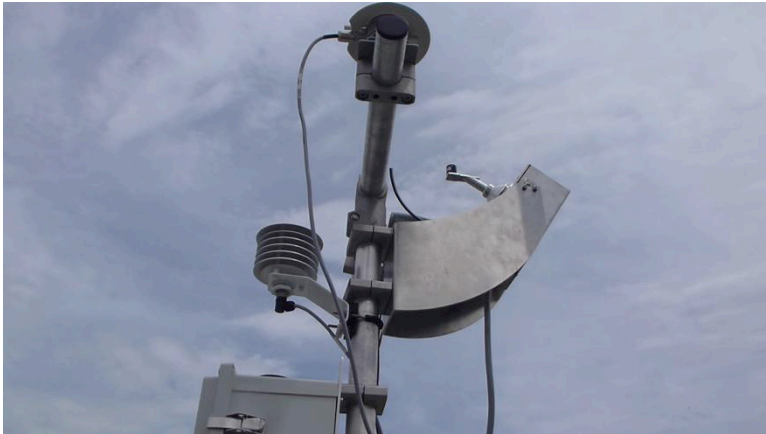
Figure 14. Sensors of Tier 2 station (RSP, SR20, Thermohygro & soiling sensor) at VNDAN

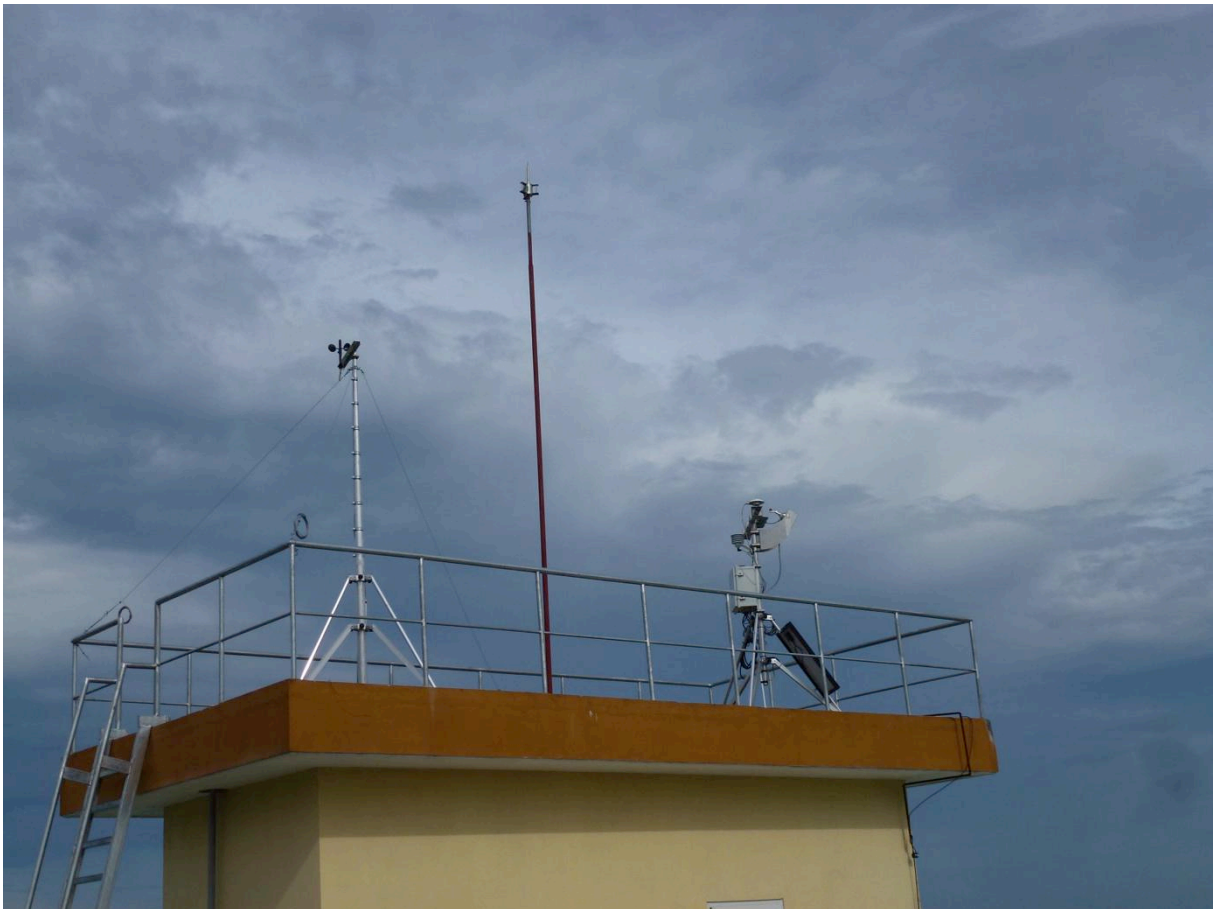
Figure 19. Tier 2 station with wind mast (left) and lightning protection (middle) on rooftop at VNDAN

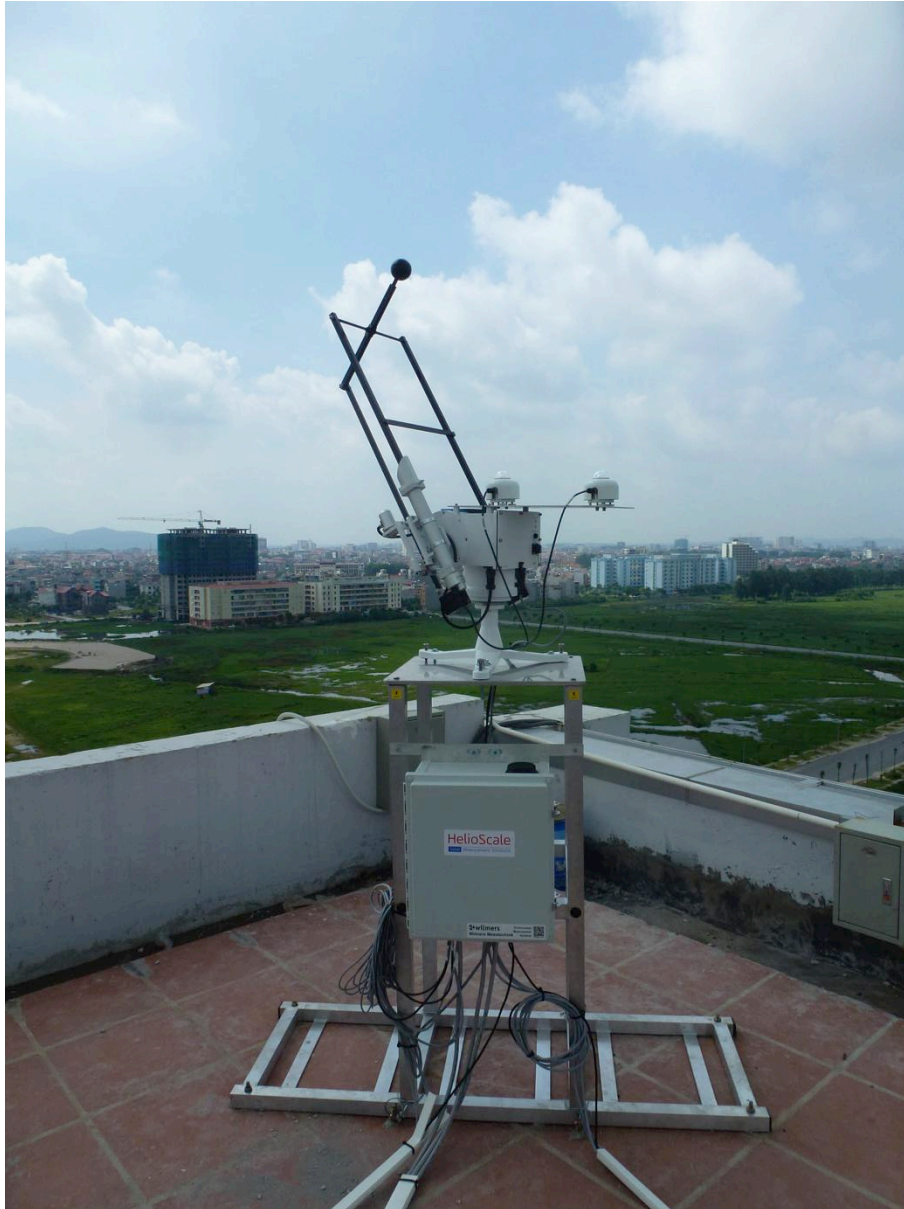
Figure 4. Photo of Tier 1 Station of type HelioScale ω installed at VNHAN

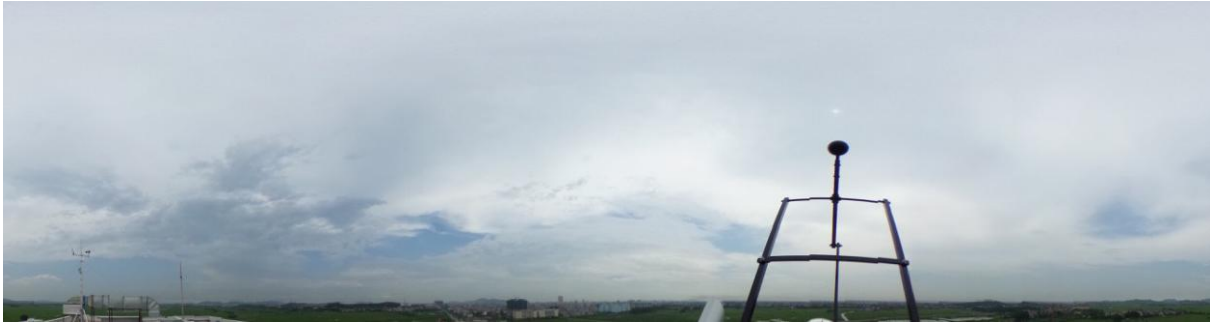
Figure 5. Horizon at VNHAN

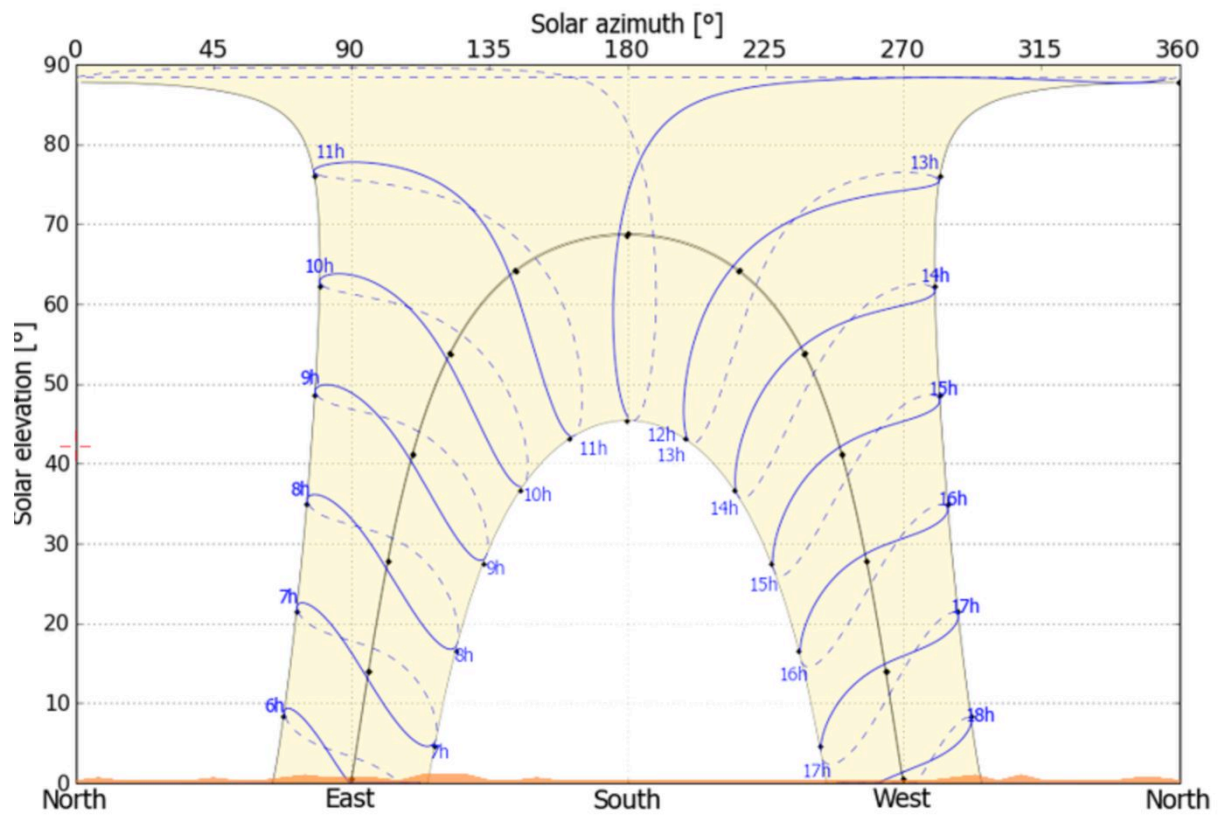
Figure 6. Sun path for VNHAN

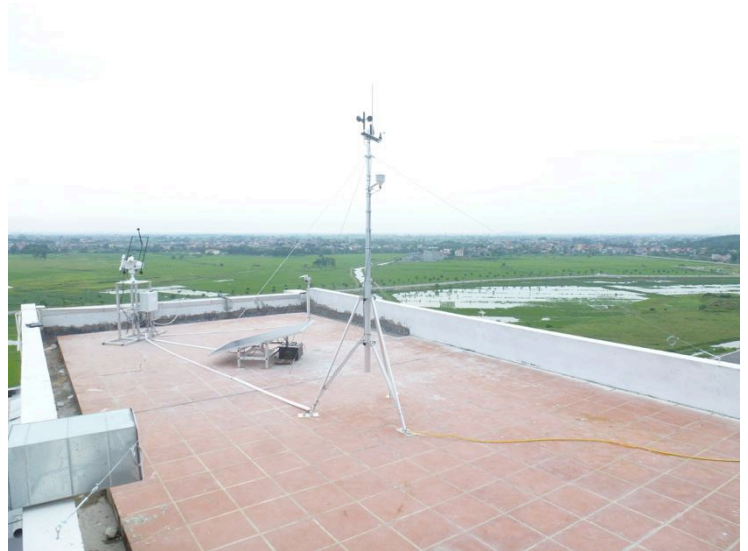
Figure 11. Tier 1 station with wind mast and soiling measurement at VNHAN

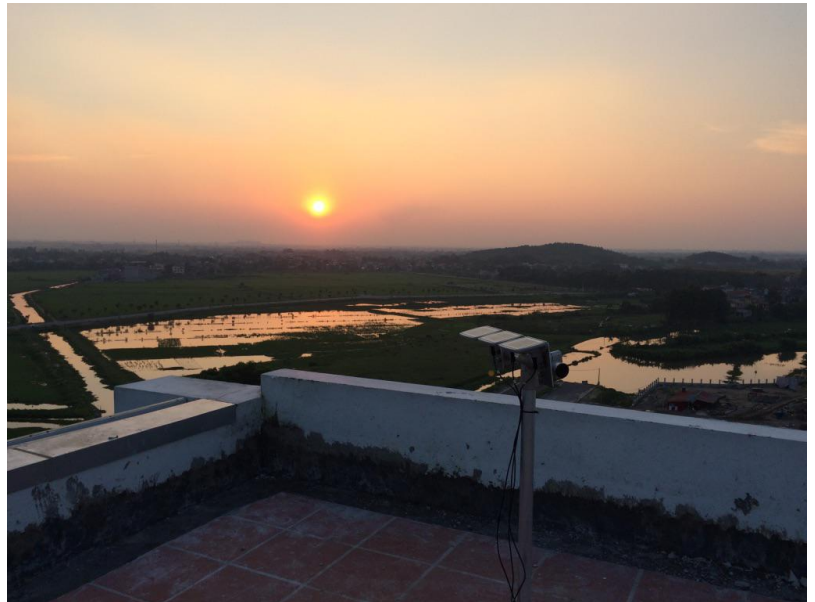
Figure 13. Soiling measurement system at sunset at VNHAN

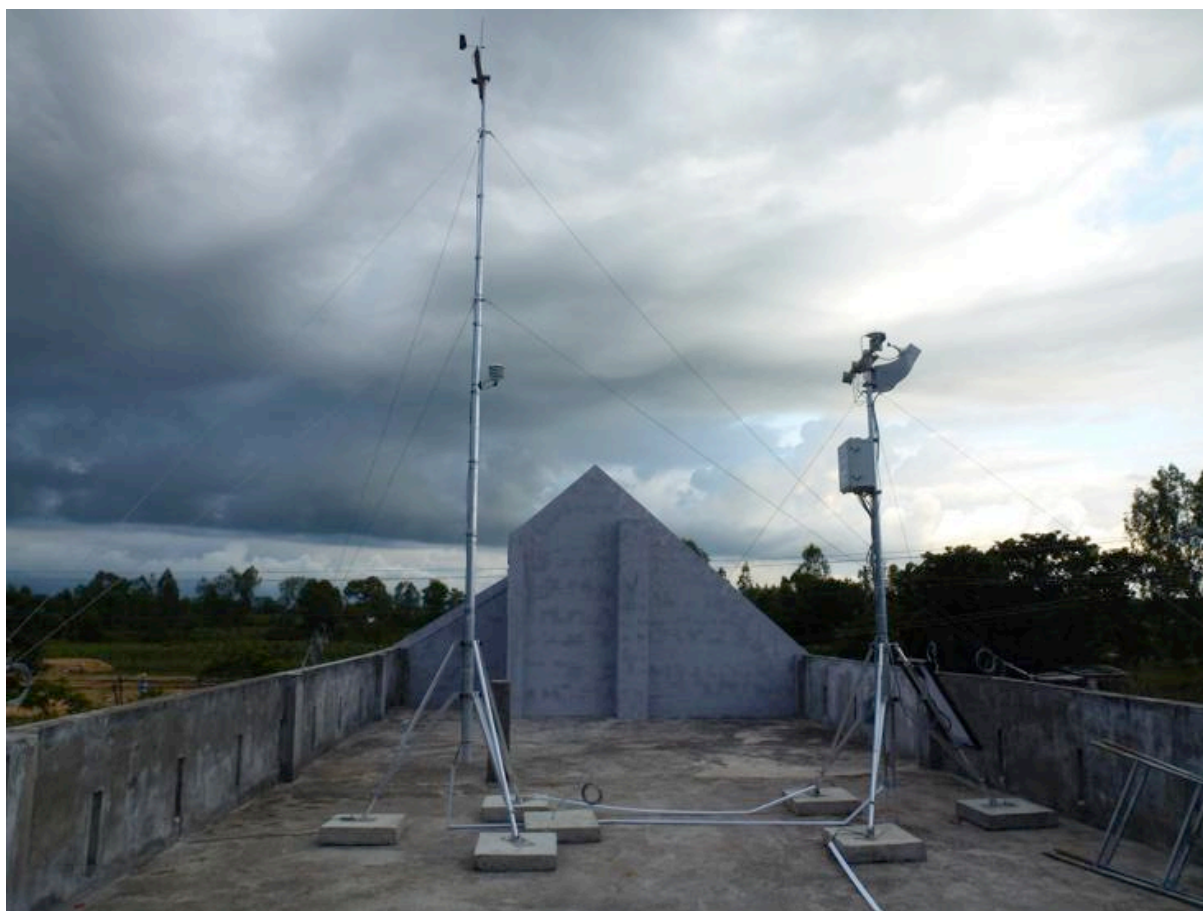
Figure 4. Photo of Tier 2 Station of type HelioScale ϕ installed at VNSOB

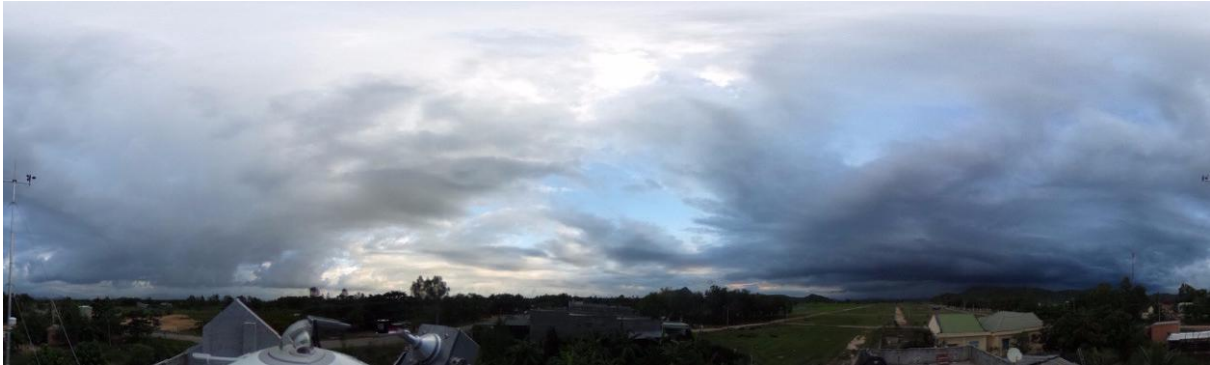
Figure 5. Horizon at VNSOB

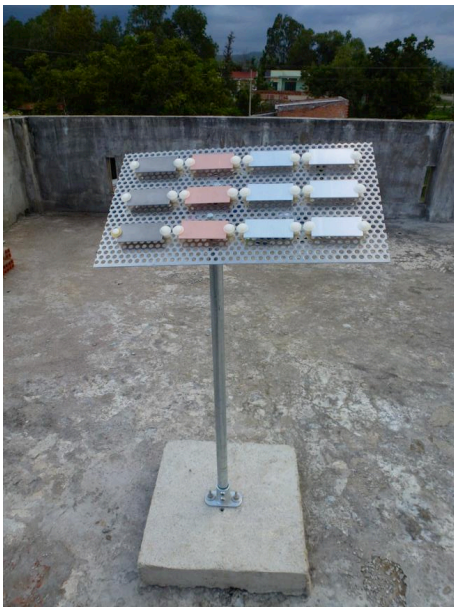
Figure 16. Corrosion measurement kit

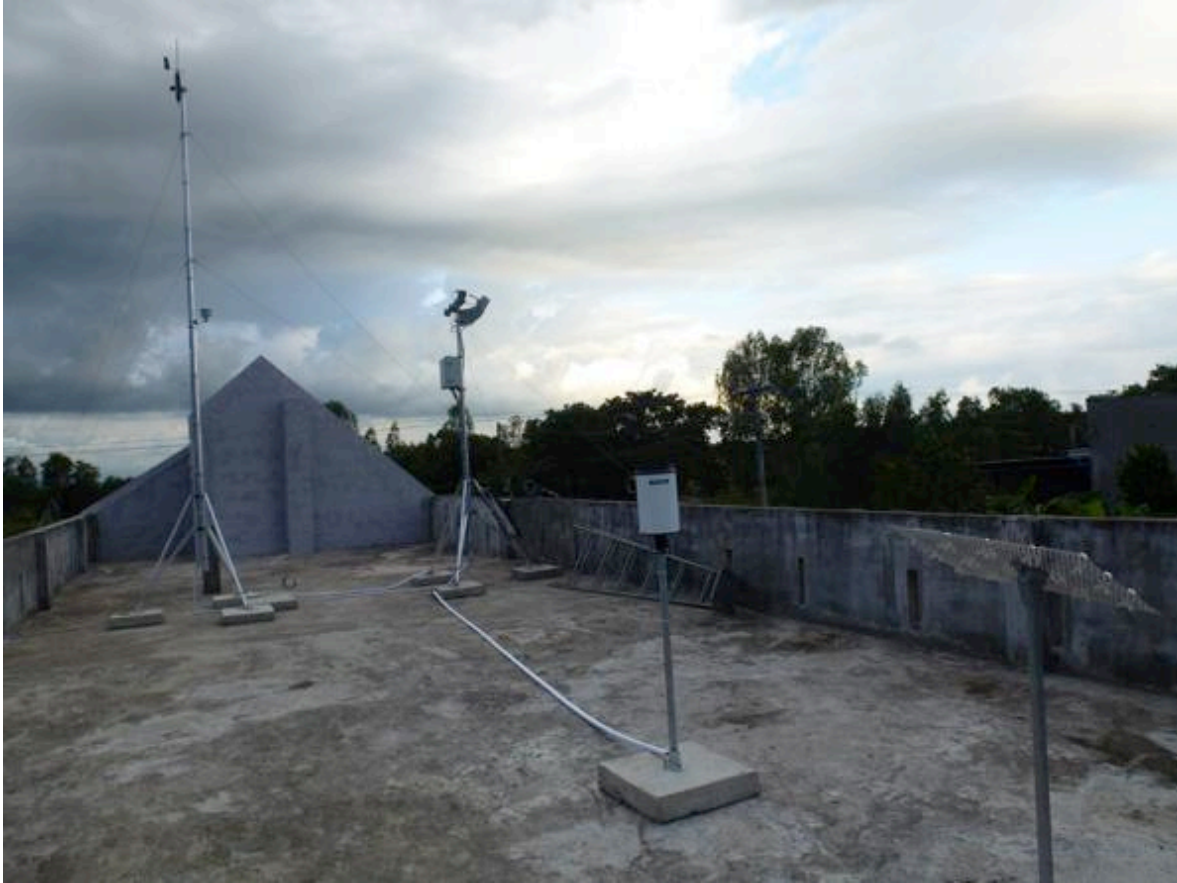
Figure 19. General view of VNSOB station: wind mast (far left), Tier 2 station and soiling system (far right), rain gauge (center) and corrosion kit (near right).

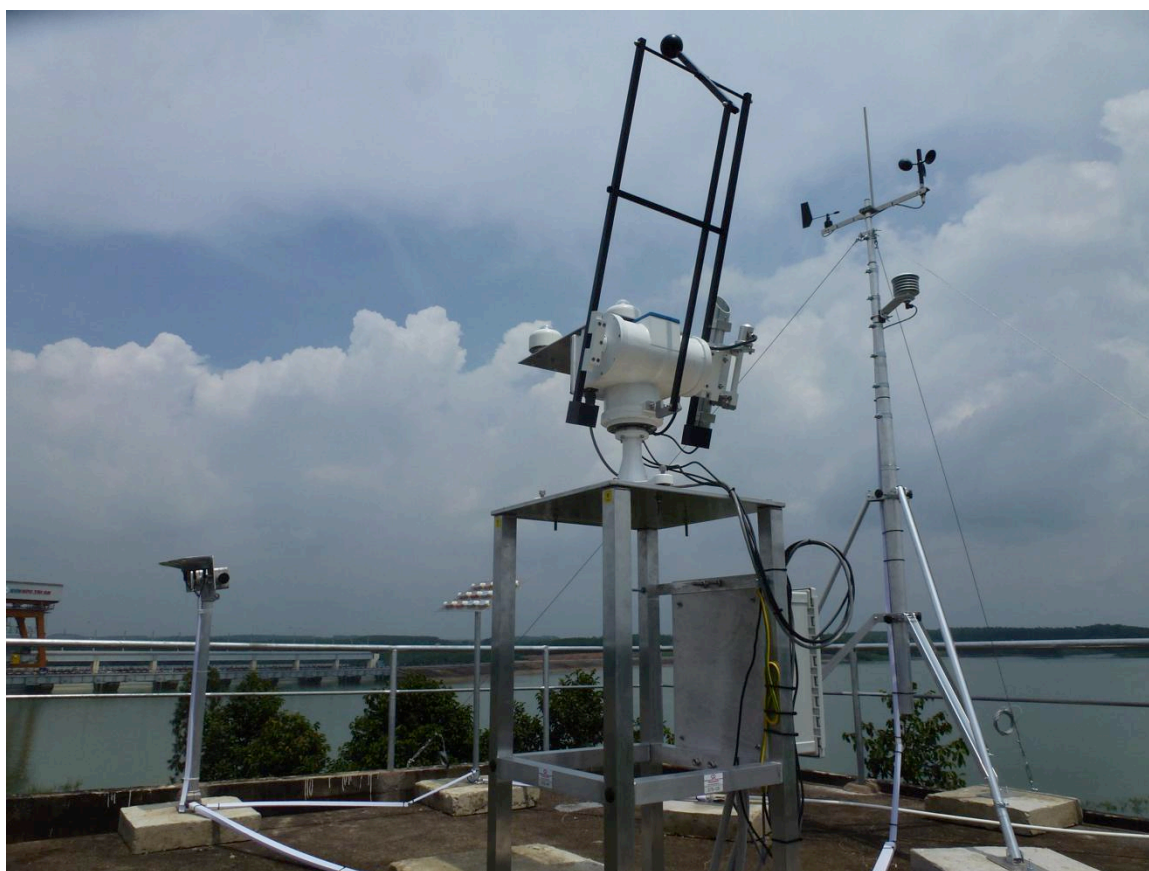
Figure 4. Photo of Tier 1 Station of type HelioScale ω installed at VNTRA

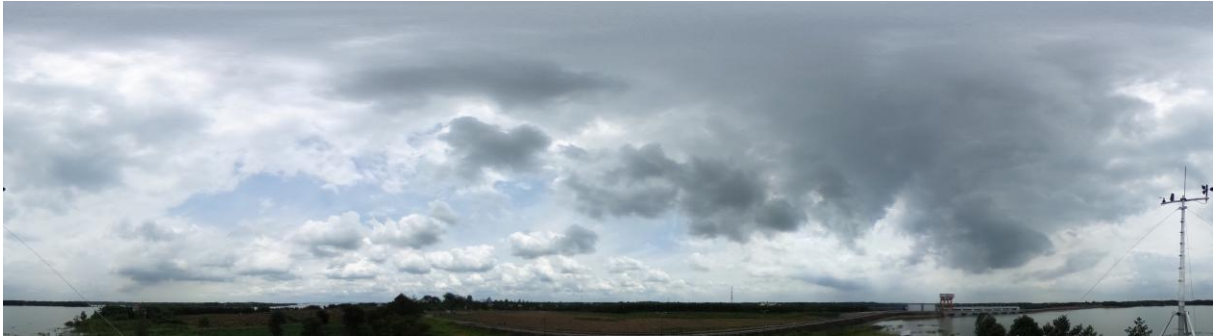
Figure 5. Horizon at VNTRA

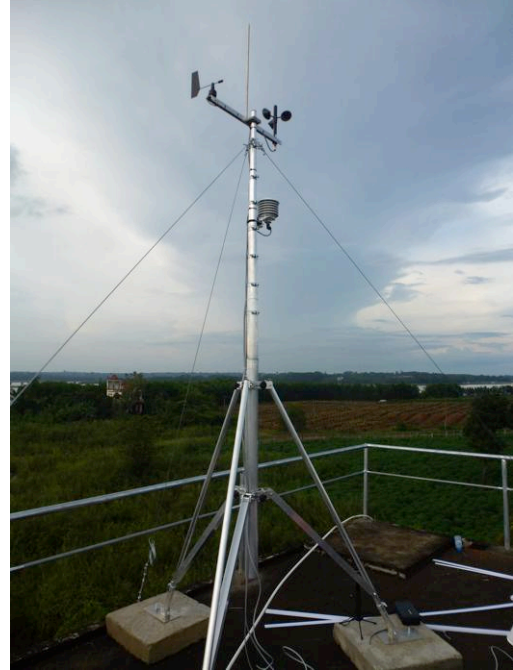
Figure 11. Wind mast measuring wind speed & direction and thermo-hygro sensor at VNTRA

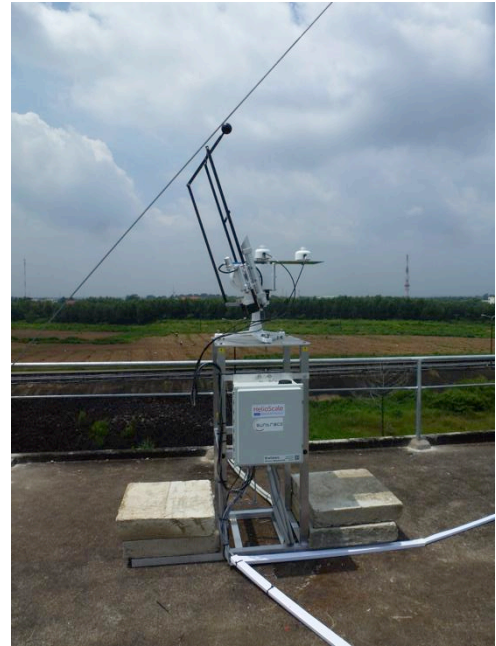
Figure 15. Tier 1 station with data logger in the front at VNTRA

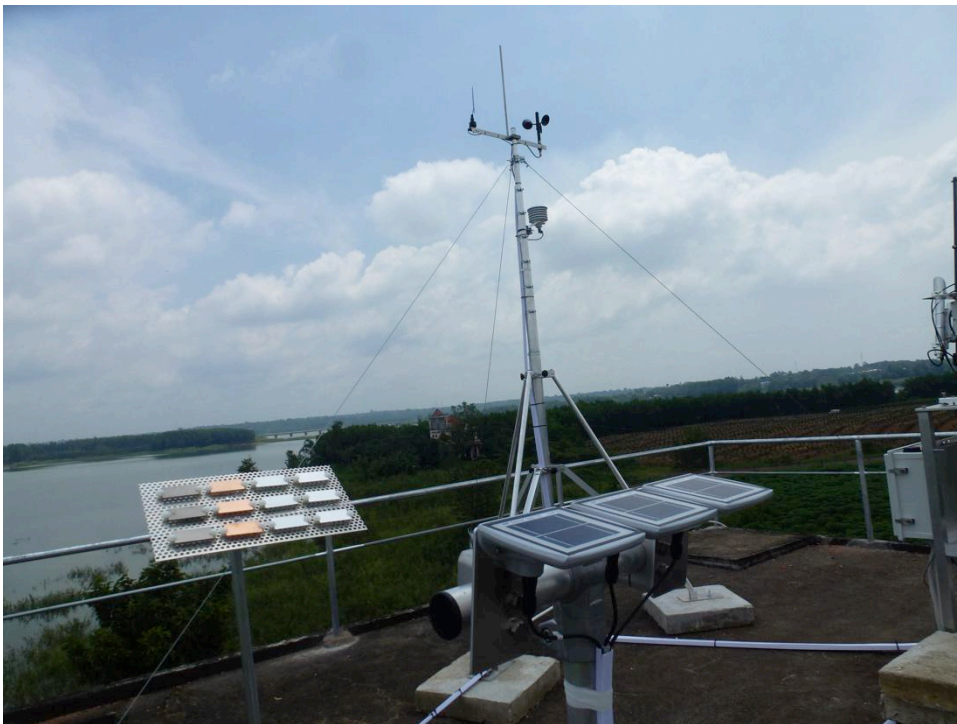
Figure 16. Corrosion measurement kit (left), soiling measurement system (front), wind mast (back) at VNTRA
