Environmental and Social Assessment Report

Rehabilitation of Cunha Relief Channel and Structures

Revised Issue C, January 2015.

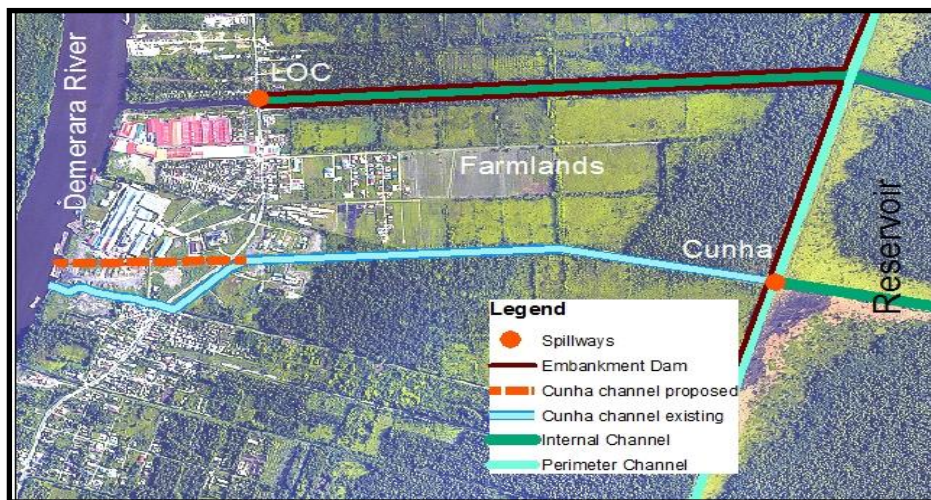
Figure 4: Reinstatement of the Cunha channel to its original alignment

The Cunha Canal is located on the western side of the EDWC and discharges into the Demerara River. Discharge from the canal, at the moment, is affected by the high tides and encroachment in the vicinity of the EBD Public Road and the Demerara River. Around 1990, the Canal was diverted from its original alignment in the vicinity of the EBD Public Road to a smaller discharge channel. This diversion reduced the discharge capacity of the Canal. Sometime later the Canal went into disuse. The discharge through the canal was resuscitated during the floods of 2005. However, the discharge capacity is affected by several factors. The proposed physical works will include the widening of the channel of the Canal, the rehabilitation of the former outlet structure and construction of a bridge on the EBD Public Road where the canal intercepts the road. The project will result in the Canal returning to its original alignment.

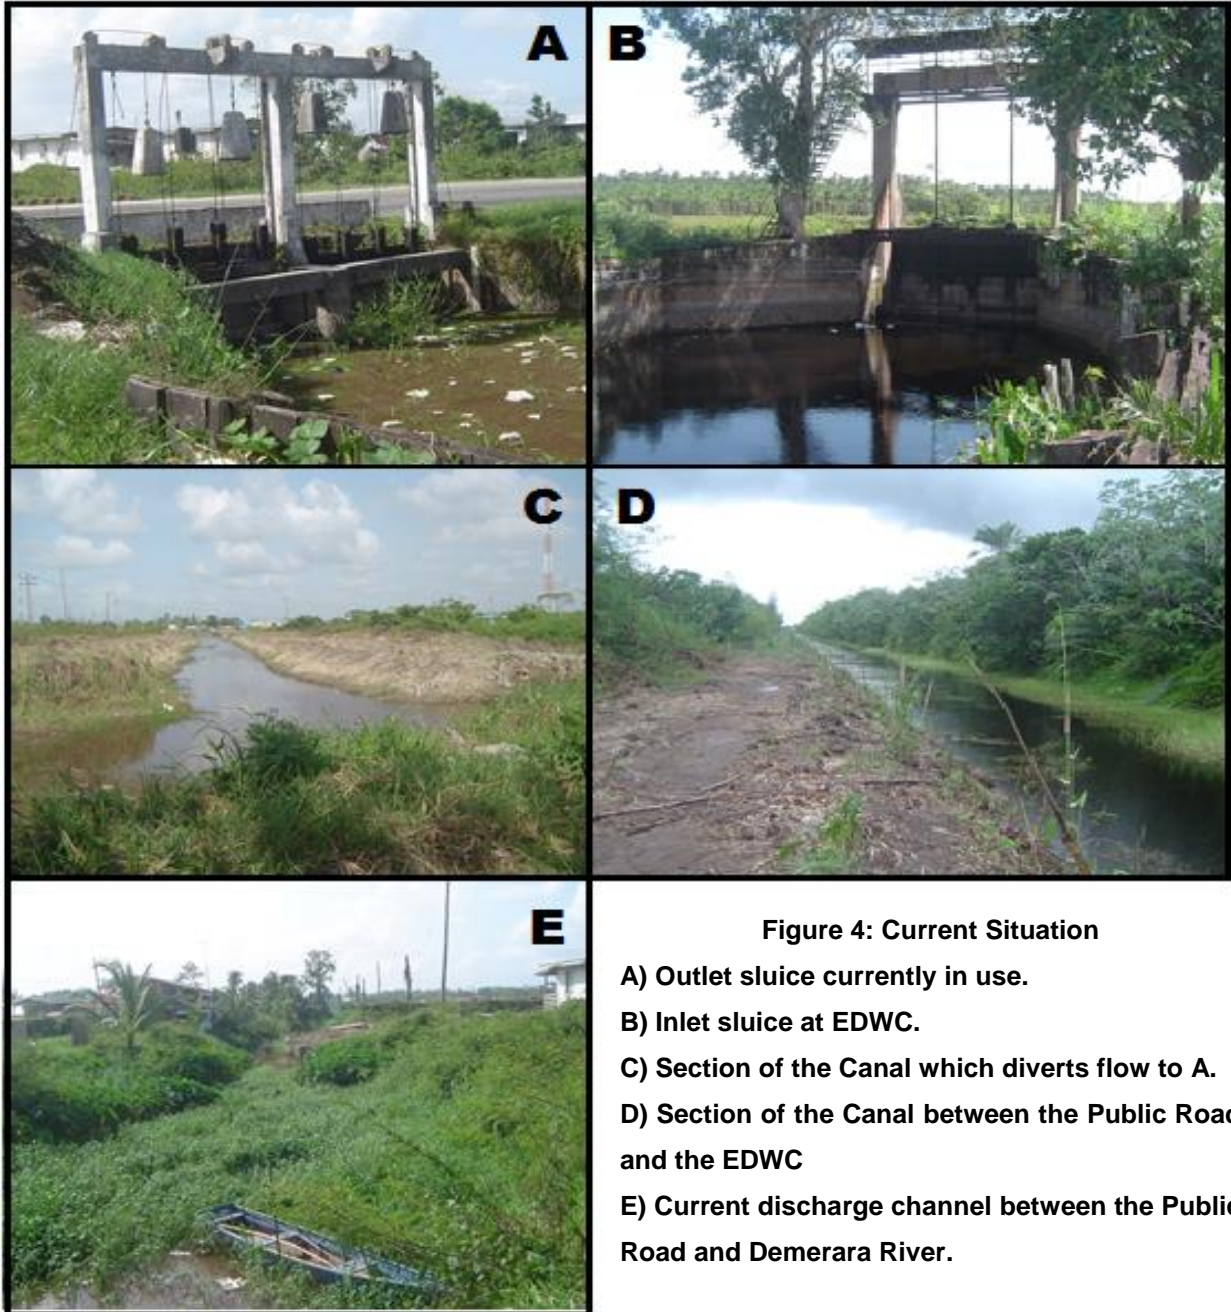
Figure 4: Current Situation

Land of Canaan (LOC). In addition, the discharge channel of the Canal in the vicinity of the Public Road was altered with the establishment of BCL Plywood and Sawmilling operations. Previously, the Canal flowed straight to the Demerara River through a sluice which was located along the Old Public Road. However, this area was sold to the Company around 1990 and the Canal was subsequently diverted south west along the new EBD Public Road and then through a sluice located between Land of Canaan and Sarah Johanna. The Canal was brought back into use following the 2005 floods when some rehabilitation works were done. The current situation is presented in Figure 4.

- A) Outlet sluice currently in use.**
- B) Inlet sluice at EDWC.**
- C) Section of the Canal which diverts flow to A.**
- D) Section of the Canal between the Public Road and the EDWC**
- E) Current discharge channel between the Public Road and Demerara River.**

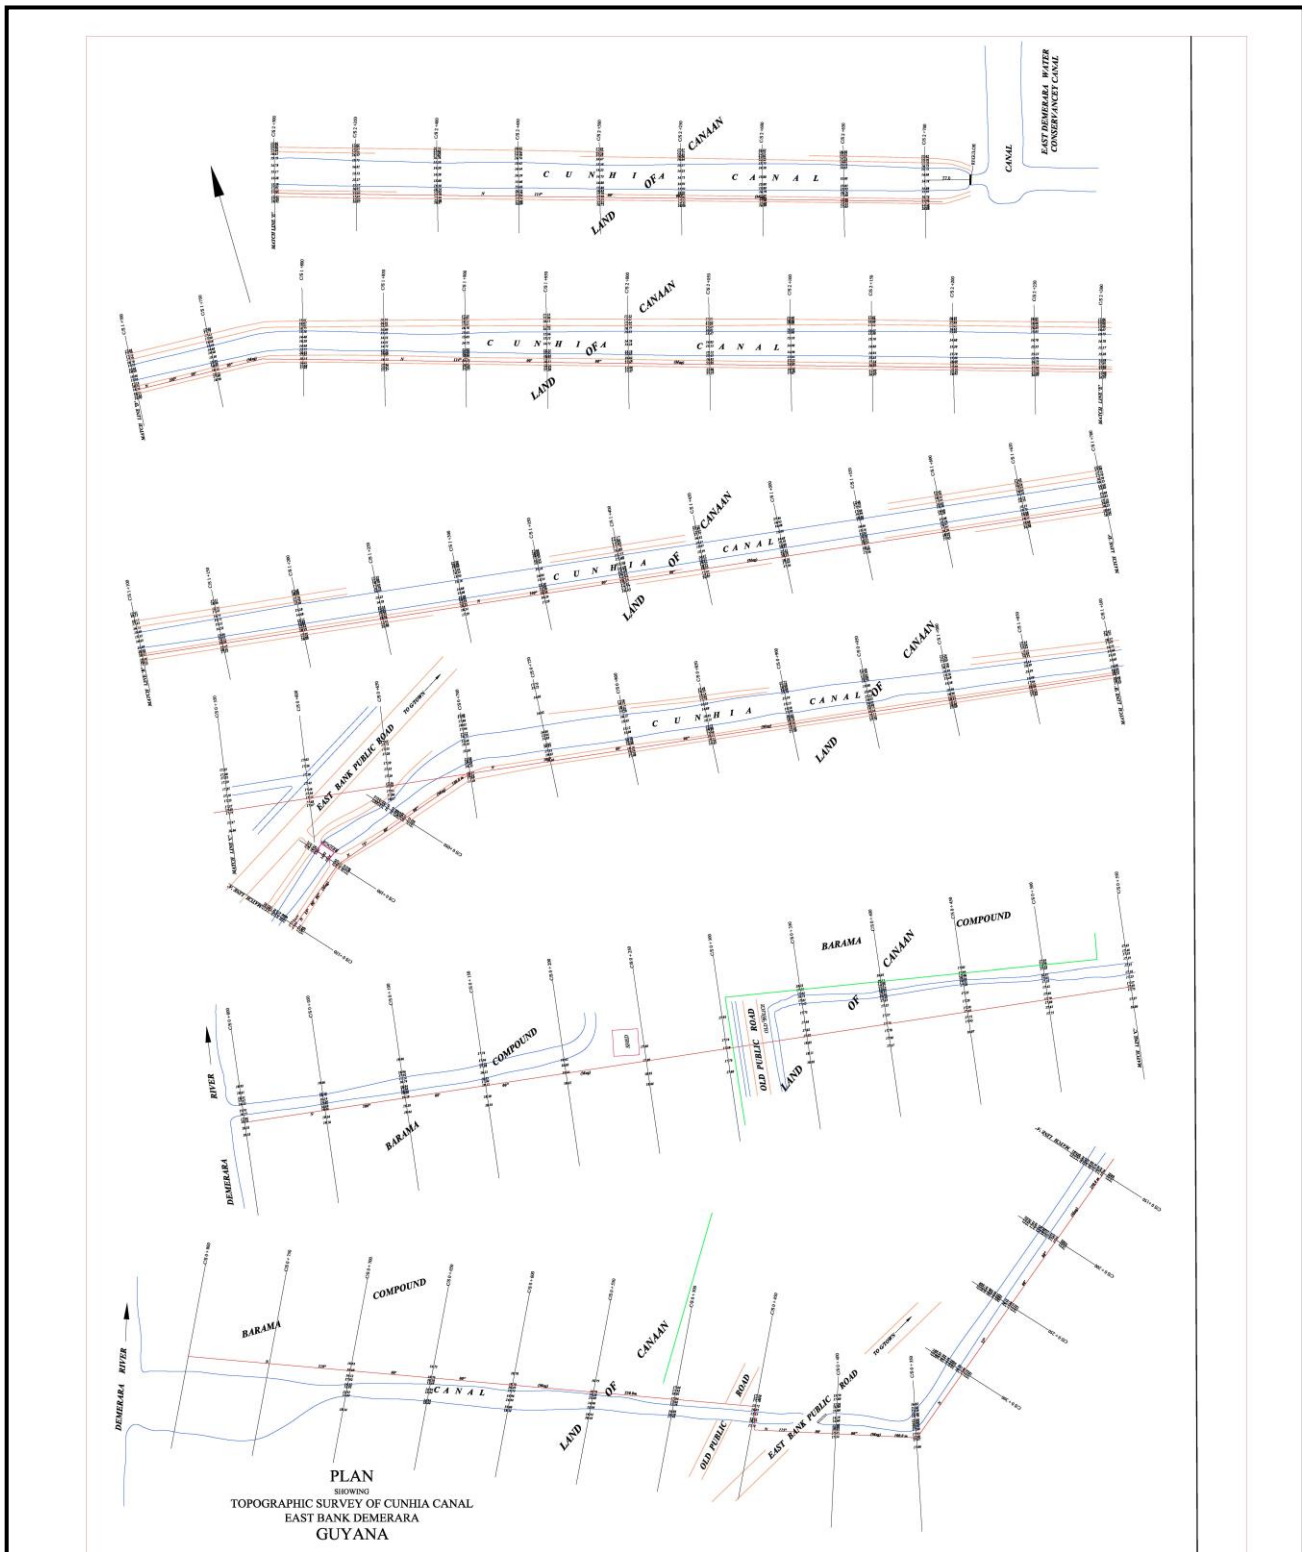
Figure 5: Map showing the current and proposed alignment of the Cunha Canal

The restoration of the defunct realignment of the channel to its original alignment will address these inefficiencies. A map of the existing and proposed alignment of the channel is shown in Figure 5.

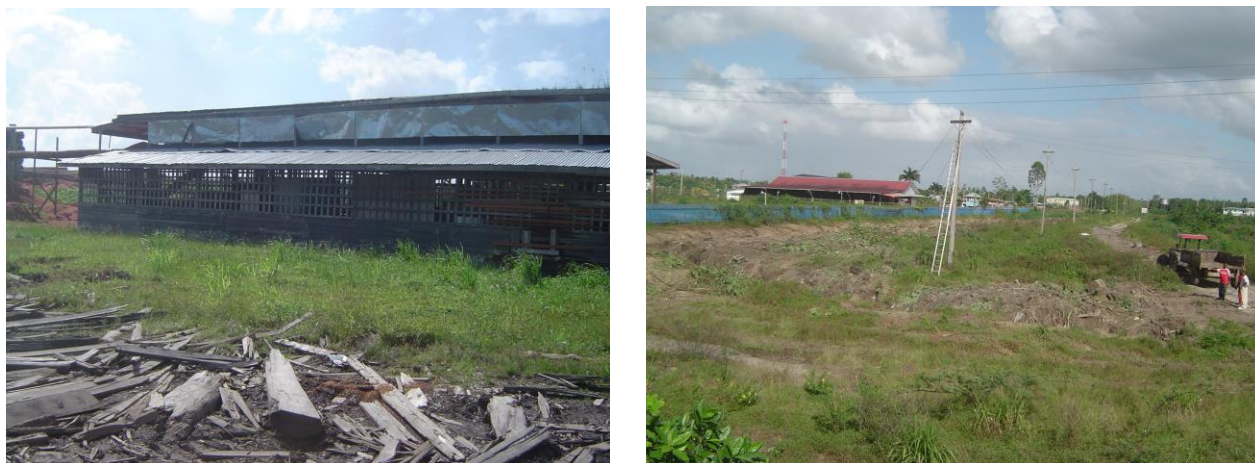
Figure 7: Secondary processing shed and the fence that would have to be relocated.

When the Canal was diverted to the current channel, BCL utilised the area along the old alignment between the sluice and the Demerara River for its operations. Some aspects of the operations are

currently located in close proximity to this alignment. These include a log pond, a secondary processing operation and a dust containment bin. The realignment of the canal to its original alignment will require some changes to the BCL operations. A survey was done to determine the buildings and other structures that would be affected. The result of this survey is outlined in Appendix F. The main building to be affected would be the Secondary Processing Shed. This is a large shed that house several pieces of equipment. Other areas to be affected include a fence on the southern boundary of the compound, a guard hut and a generator shed. Two (2) bridges that link the Company's log pond with the rest of the operation will also be affected.

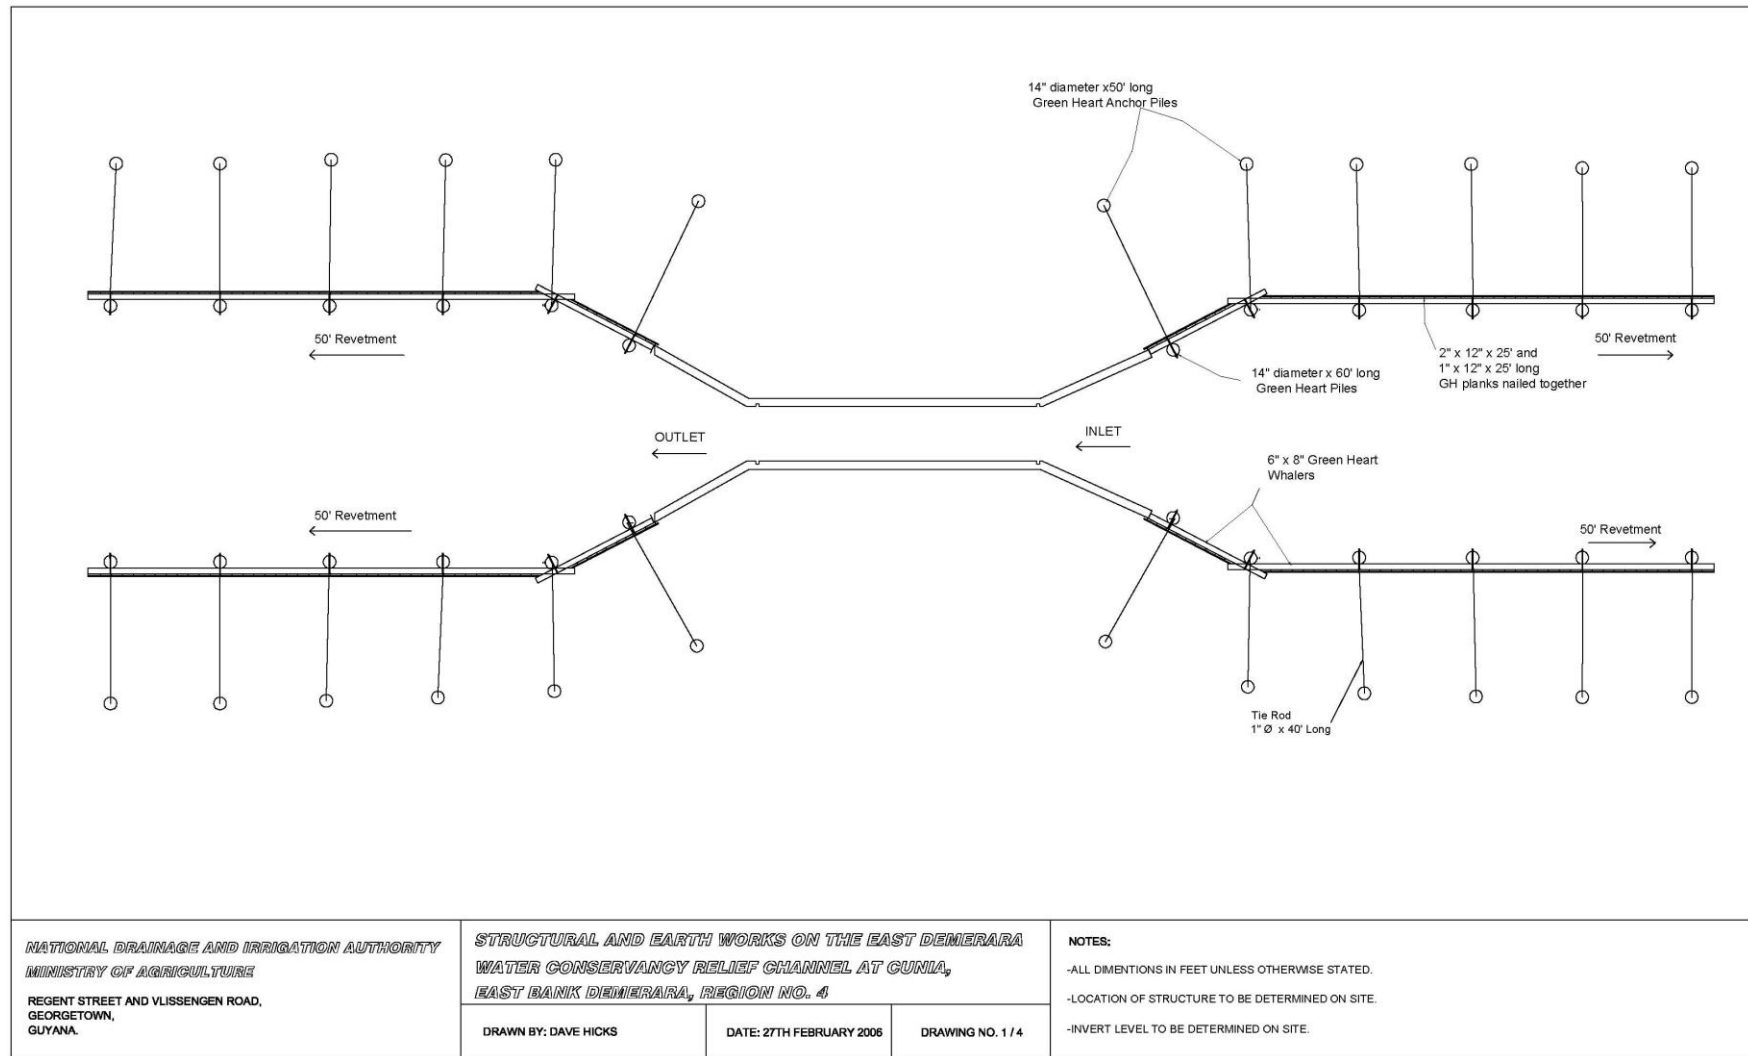
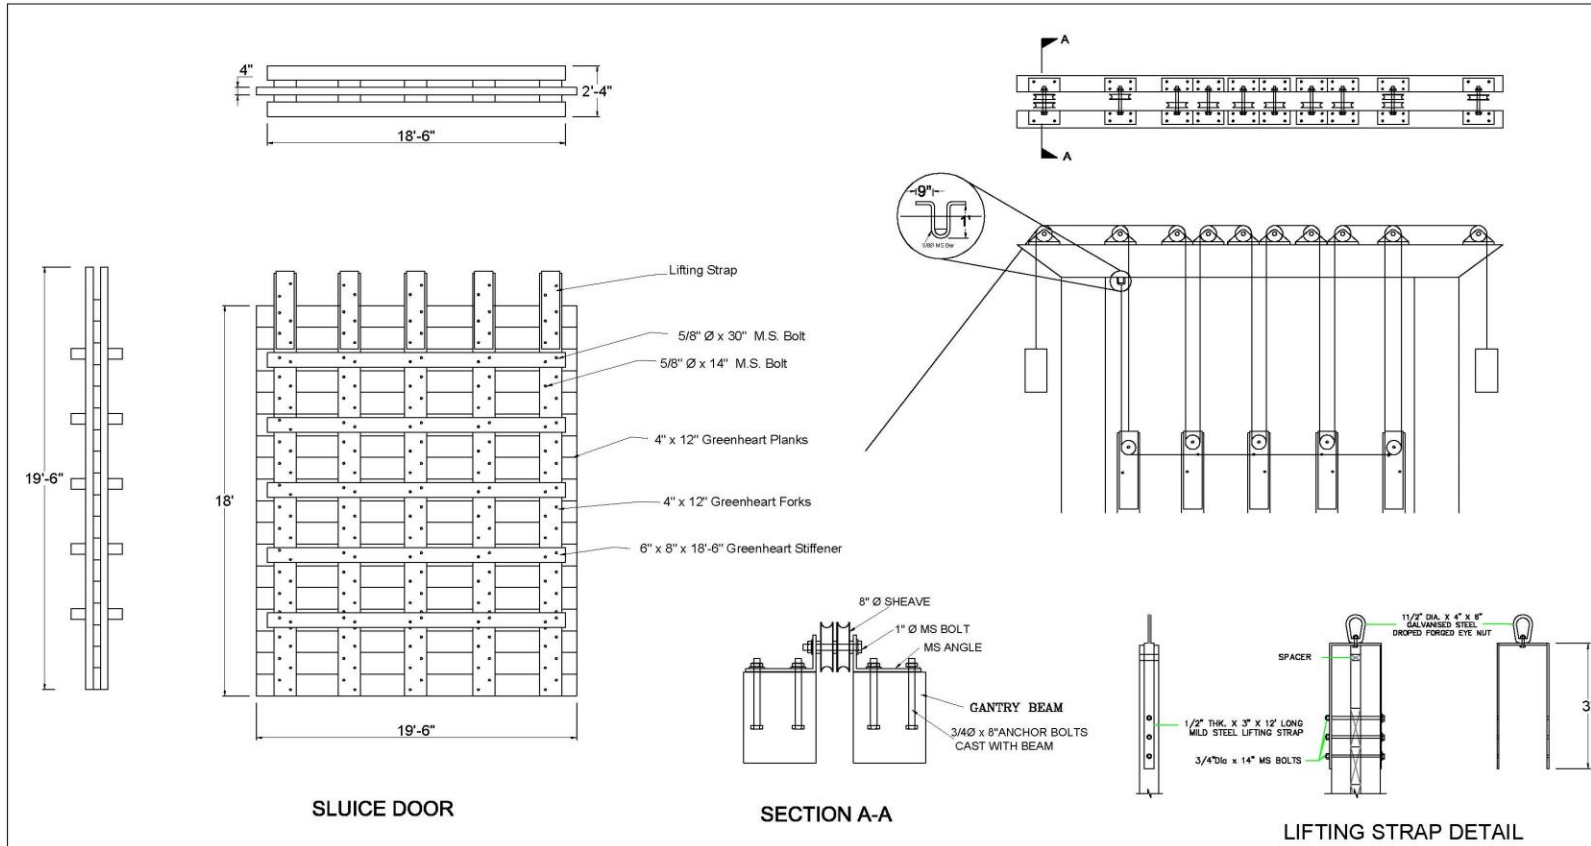
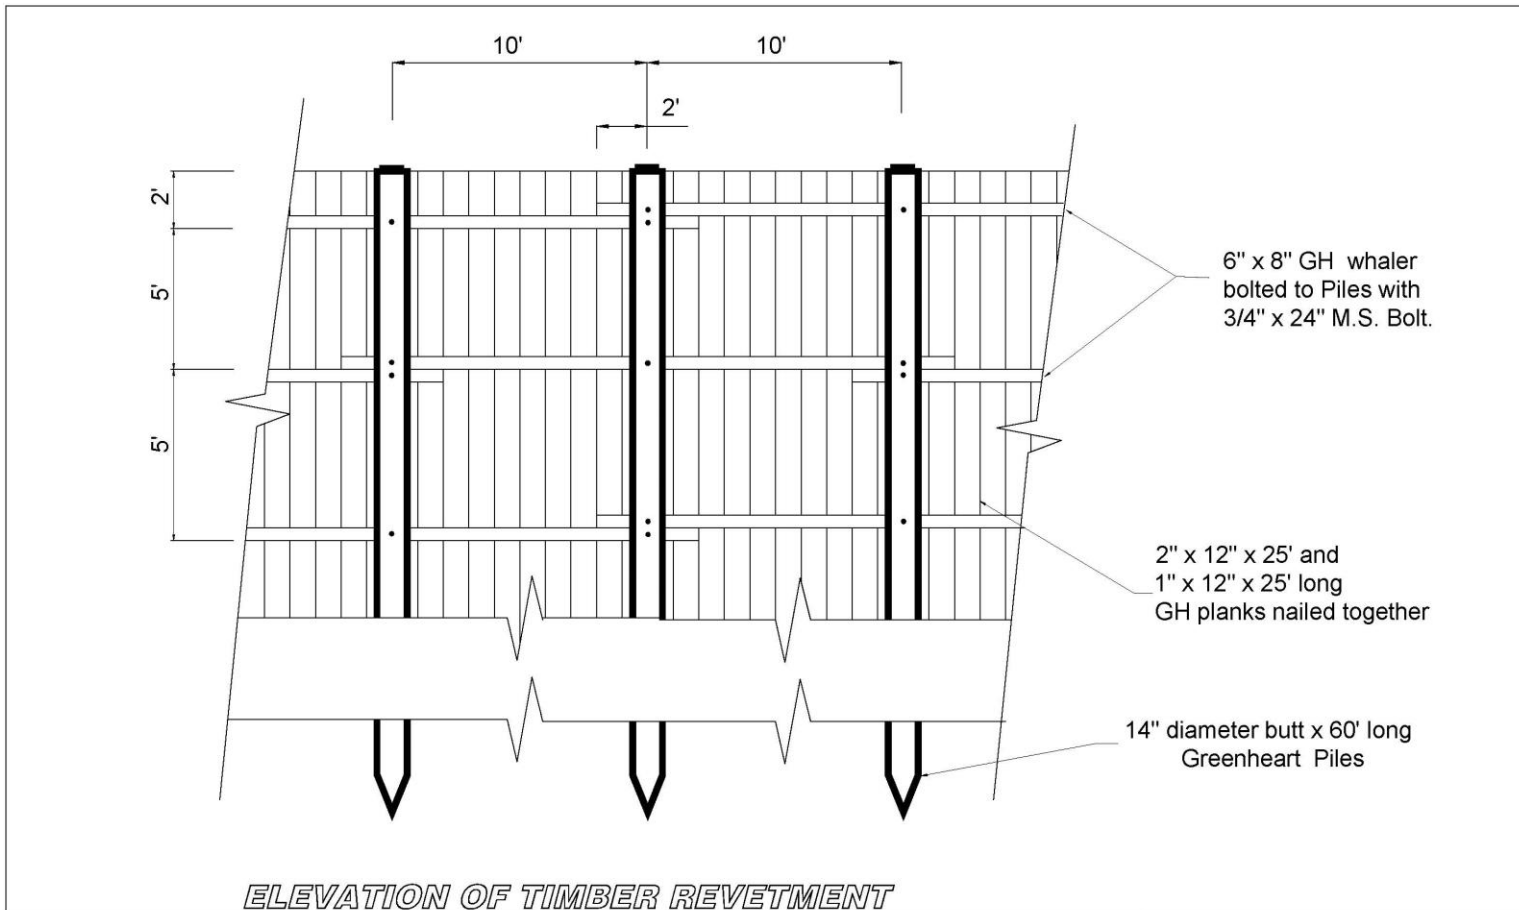
Appendix D – Drawings of the Sluice to be rehabilitated

<p>NATIONAL DRAINAGE AND IRRIGATION AUTHORITY MINISTRY OF AGRICULTURE REGENT STREET AND VLISSENGEN ROAD, GEORGETOWN, GUYANA.</p>	<p>STRUCTURAL AND EARTH WORKS ON THE EAST DEMERARA WATER CONSERVANCY RELIEF CHANNEL AT GUNIA, EAST BANK DEMERARA, REGION NO. 4</p>	<p>NOTES: -ALL DIMENSIONS IN FEET UNLESS OTHERWISE STATED. -LOCATION OF STRUCTURE TO BE DETERMINED ON SITE. -INVERT LEVEL TO BE DETERMINED ON SITE.</p>	
	<p>DRAWN BY: DAVE HICKS</p>	<p>DATE: 27TH FEBRUARY 2006</p>	<p>DRAWING NO. 2/4</p>

NATIONAL DRAINAGE AND IRRIGATION AUTHORITY MINISTRY OF AGRICULTURE REGENT STREET AND VLISSGENG ROAD, GEORGETOWN, GUYANA.	STRUCTURAL AND EARTH WORKS ON THE EAST DEMERARA WATER CONSERVANCY RELIEF CHANNEL AT GUNIA, EAST BANK DEMERARA, REGION NO. 4		NOTES: -ALL DIMENTIONS IN FEET UNLESS OTHERWISE STATED. -LOCATION OF STRUCTURE TO BE DETERMINED ON SITE. -INVERT LEVEL TO BE DETERMINED ON SITE.
	DRAWN BY: DAVE HICKS	DATE: 27TH FEBRUARY 2006

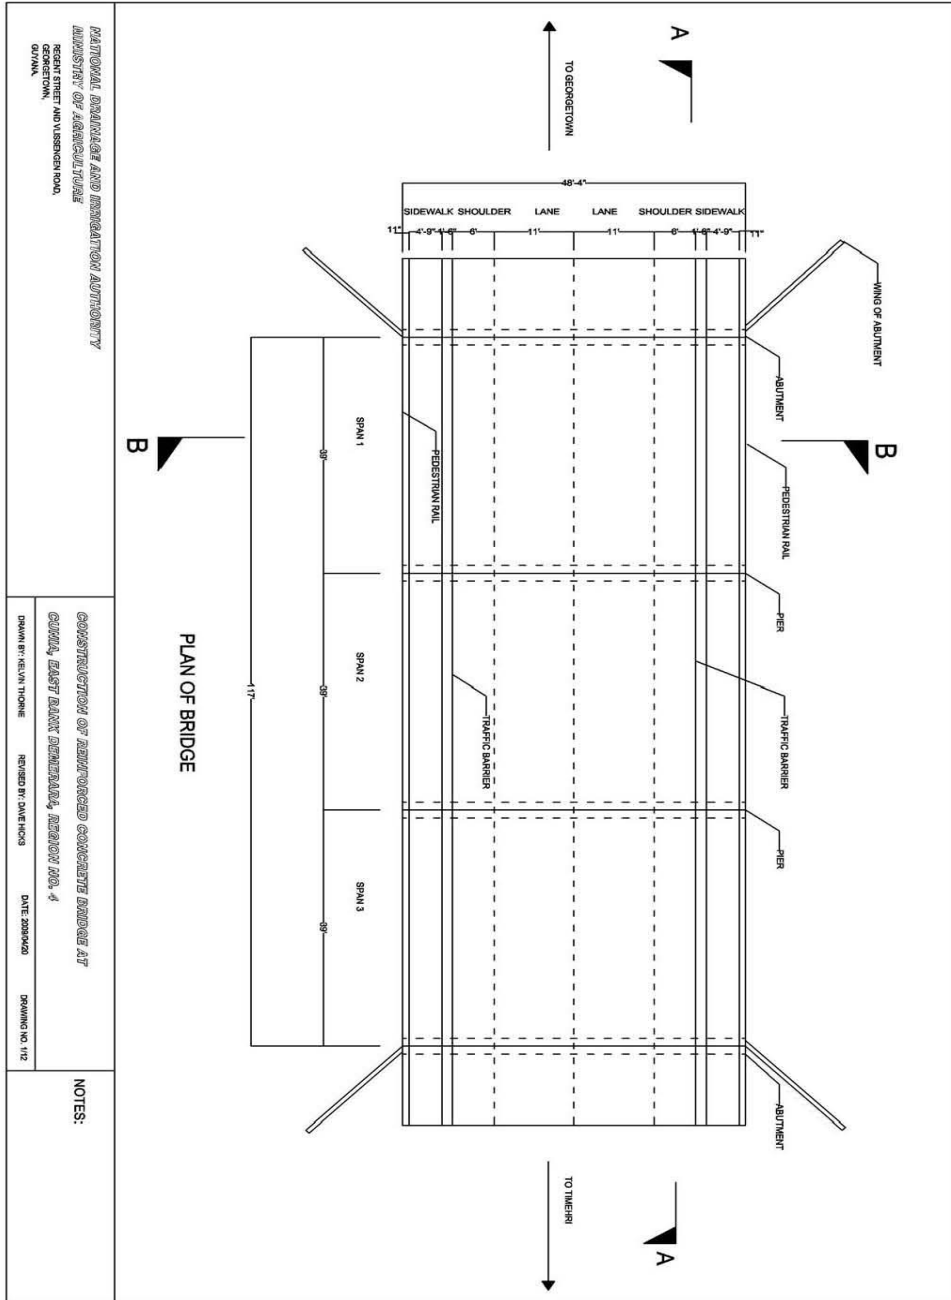
Plan of Bridge

CONSTRUCTION OF IMPROVED CONCRETE BRIDGE AT
 CUNHA EAST BANK DAMBARRA, REGION NO. 4
 DRAWN BY: KEVIN THORNE REVISED BY: DAVID HICKS DATE: 2009/02/20 DRAWING NO: 512

- Construction of a bridge across the EBD Public Road.
A new bridge will be constructed at the point where the canal will intercept the EBD Public Road to allow vehicular traffic to traverse the area. Drawings of the bridge are attached as Appendix E.
