Zimbabwe-Strategy for Managing Water Quality and Protecting Water Sources

Final Report

Phase 1: Rapid Assessment – Identification and Characterization of Hotspots of Water Pollution and Source Degradation

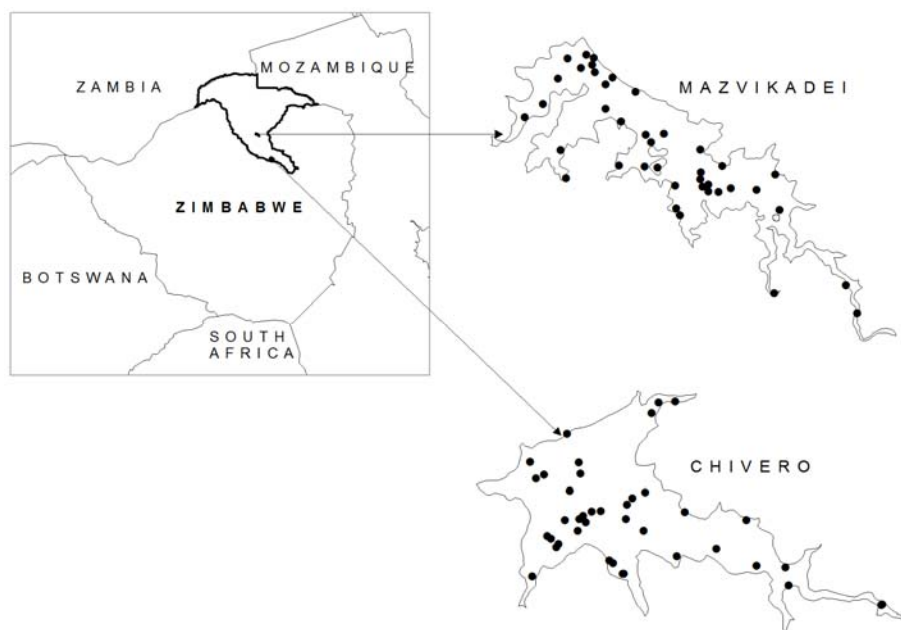
Figure 5: Map of lakes Chivero and Mazvikadei showing their location in Manyame catchment (black solid line) of Zimbabwe and the position of sample stations (solid circles).

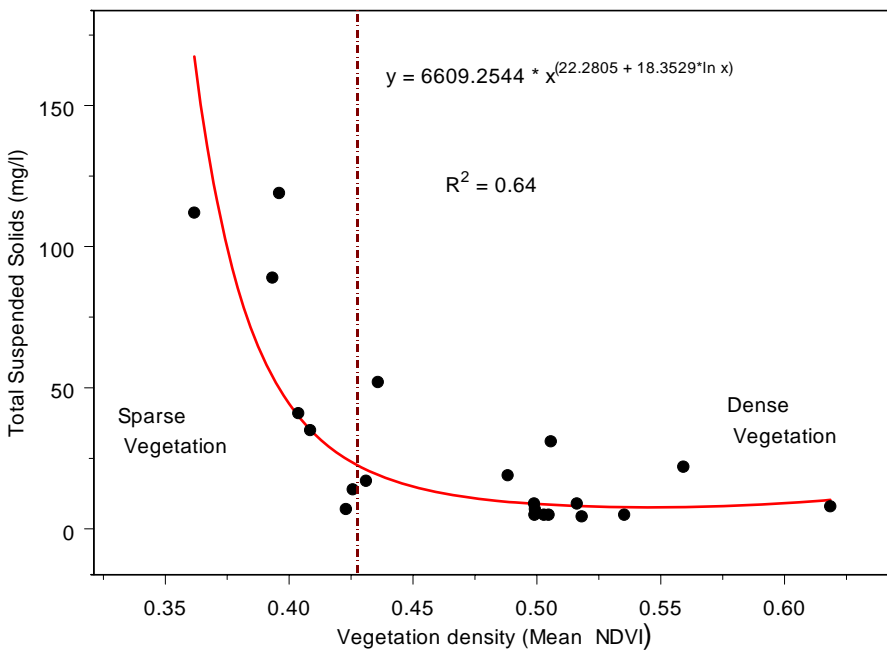
Figure 9: Relationship between Landsat 8 derived indicator of vegetation density and field measured total suspended solids (TSS) for Mzingwane and Sanyati (top) and Mazowe and Manyame catchments (bottom). The best fit non-linear regression line is displayed.

Figure 9 shows that TSS decreased significantly as the mean vegetation density increased for both the drier (Sanyati and Mzingwane) and wetter (Mazowe and Manyame) catchments.
