Solar Resource Mapping in Pakistan

SITE EVALUATION REPORT

Site evaluation report: Baluchistan University of Information Technology, Engineering and Management Sciences

DOC: SiteEvalReport_Quet_2015-04

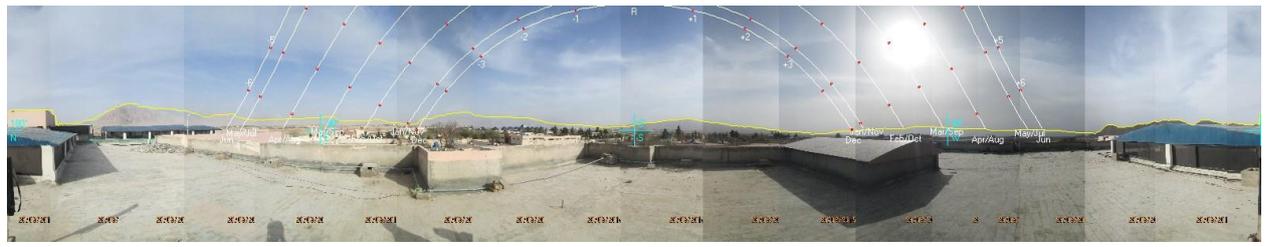
Figure 5: Panoramic View with North, South, horizon line and monthly sun paths with the corresponding position at full hours marked

The picture in Figure 5 shows a panoramic view with a centered south view, North is on the left and right edge of the picture. Blue markers show the North, South, East and West direction as well as horizon height. The sun paths throughout the year are displayed in the picture, revealing if any objects on the horizon are imposing an obstruction to the direct solar irradiance.

From the panoramic view, it is visible that no obstacles such as trees on the horizon are blocking the sun. There are mountains on the horizon, which are part of the natural environment and can be considered in the data analysis. Also in the satellite data model, the terrain can be integrated via 3D-models of the surroundings. Their shading impact is further analyzed in the following paragraphs.

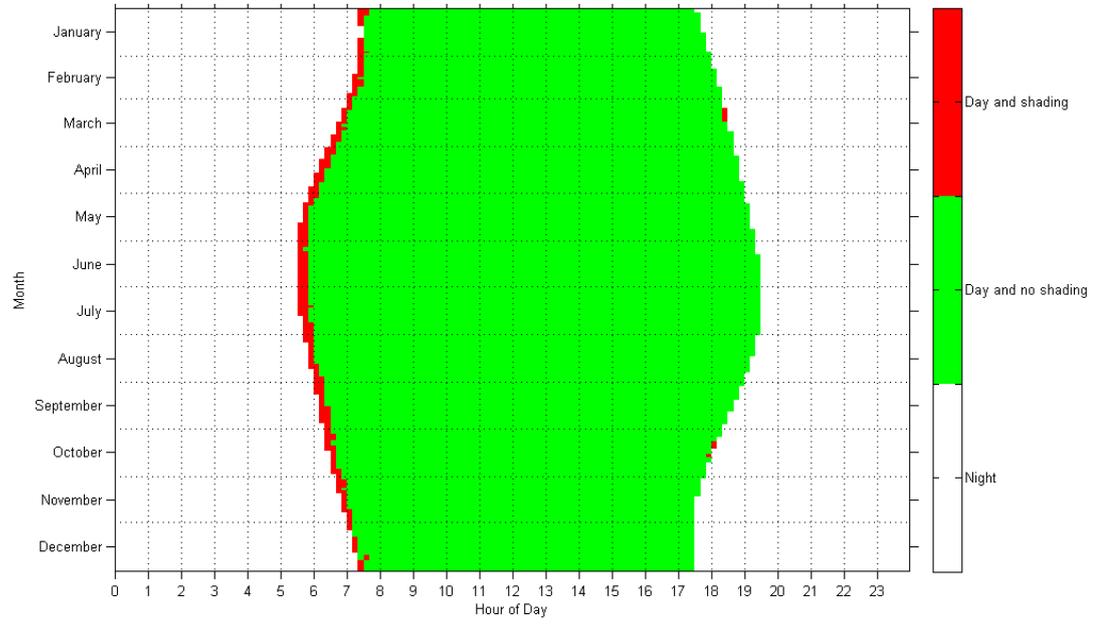
Figure 6: Shading Table for Sun Elevations >0°

Figure 6 shows the shading table throughout the year. It becomes clear that the mountains are shading the sun in the morning in the entire calendar year, and in the evening briefly in March and October.

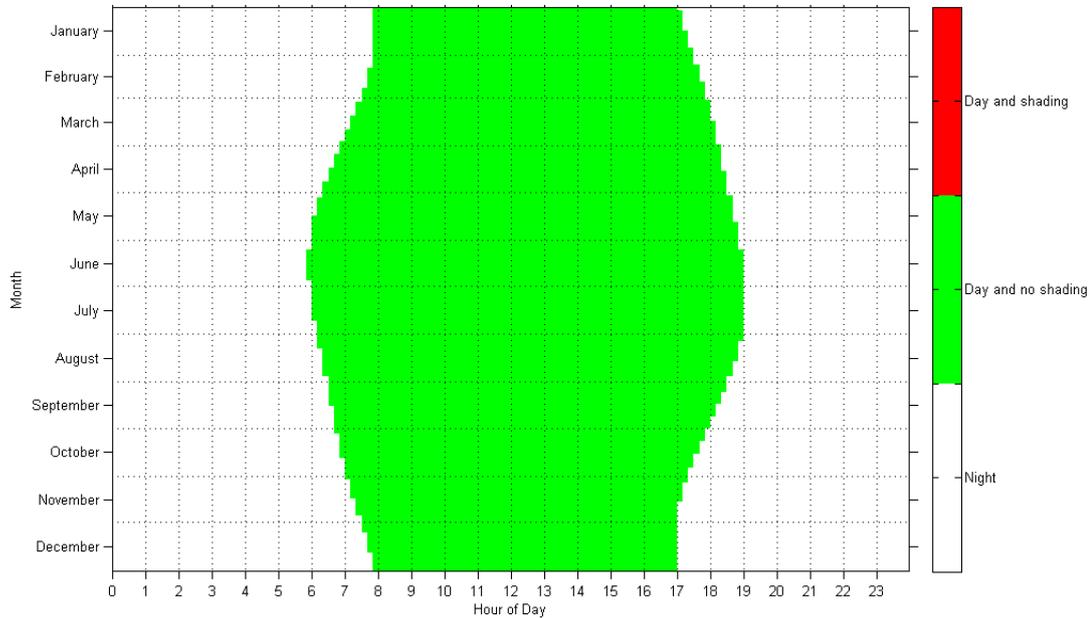
Figure 7: Shading Table for Sun Elevations >5°

Figure 7 shows the shading table after excluding Sun Elevations smaller than 5° above horizon. At these low angles, measurement uncertainty of satellite and ground measurement is elevated due to the large cosine error, and the data from these periods is therefore excluded from the satellite data adjustment and validation. Also from the view of any solar power installation (PV or CSP), sun elevation smaller than 5° is usually not contributing to electricity or heat generation due to shading, unfavorable incidence angles and low irradiance intensity. *Subsequently, all further graphs and evaluations refer to sun elevations larger than 5°, as the main aim of the measurements on ground is the adjustment of the long-term satellite data.*

From the graph, it is visible that shading from the mountains is not occurring in the data after exclusion of sun elevations smaller than 5°.

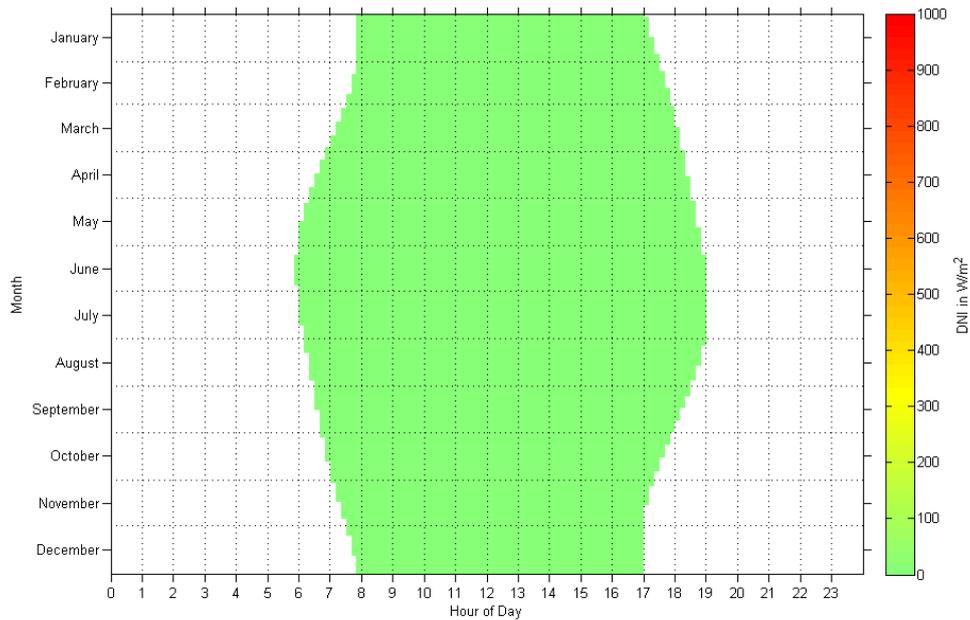
Figure 8: Shading Impact on BirdDNI for Sun Elevations >5°

Figure 8 shows the impact of shading on direct normal irradiation (DNI). DNI is modeled according to Bird (Bird et al., 1991) as a theoretical clear-sky DNI throughout the year and can be interpreted as the maximum solar resource. The impact of shading on this figure is therefore the maximum quantitative impact shading could have on solar resource.

From the figure, it is obvious that shadings have no impact on the total DNI measurement throughout the year. In total, 0% of the time (sun elevation >5°) is affected by direct shading.
