**FEDERAL DEMOCRATIC REPUBLIC OF ETHIOPIA**  
**URBAN WATER SUPPLY AND SANITATION PROJECTS:**  
**ADDIS ABABA WATER SUUPLY AND SANITATION PROJECT**  
**AND**  
**MEKELE WATER SUPPLY AND SANITATION PROJECT**

**RAP SOCIAL AUDIT**

**Assefa Tolera Sori (PhD)**

**March 2012**

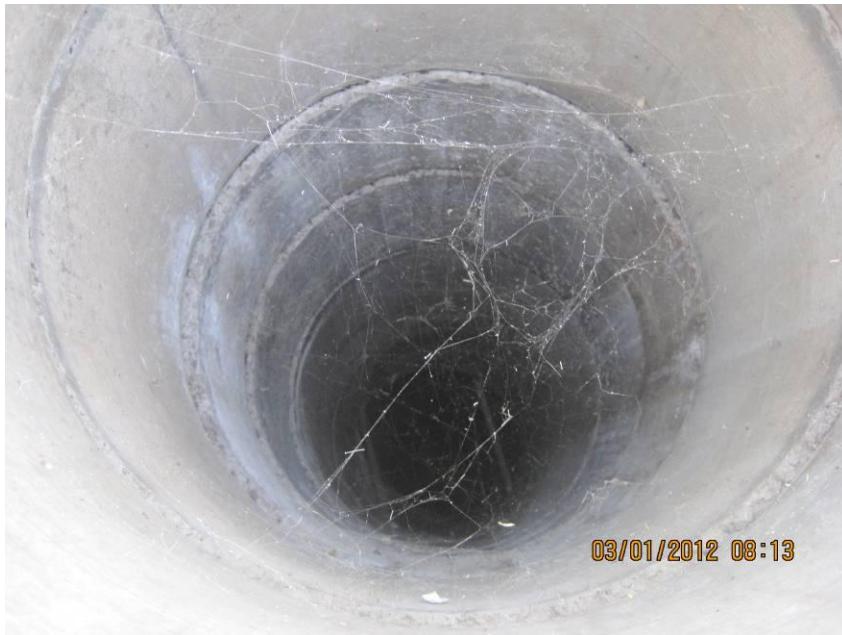
On the other hand, many informants complained that most of the hand-dug water wells they had in their homestead or villages (some communal) for many years dried up following the drilling of the test wells and the subsequent planting of the pumps, construction of transmission

pipes and channeling of water to the reservoirs. We were shown one of these dried up 15 meters deep wells and no sign of water could be seen. Although we cannot comment on the connection between the drilling of water from 500 meters deep wells and the drying up of the old hand-dug 15 meters deep wells (because of lack of competence), it was true the latter were abandoned and one could see only layers of a spider web not a water. (See photo below)

**Figure 1:** Dried and abandoned hand-dug well (Salo Gora)

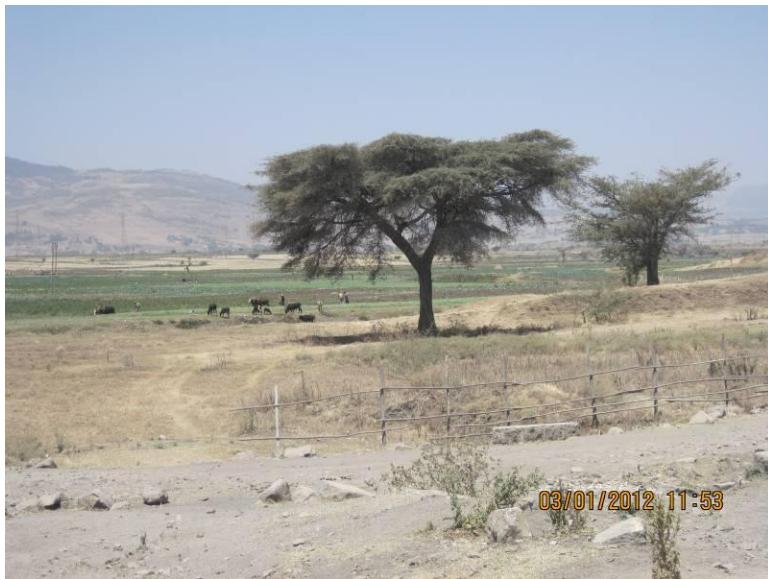
Akaki Well Field 1 (AWF1) changed to an alternate site, because as was mentioned in the ESIA report, it is the Gada ritual site for the Oromo people where every seven [eight] years people meet at that particular site and celebrate the Gada ritual and amend the existing laws and propose new laws (ESIA 2009:55). During the site visit for the purpose of this social audit, we were able to see the land still untouched and used only as grazing land (see photo below). It is worth noting that the Addis Ababa WSSP has observed the World Bank's **OP 4.11** (Physical Cultural Resources) which aims at preserving and avoiding elimination of cultural properties.

**Figure 2:** The Gada ritual site saved due to change of the AWF I to an alternate site
